# Roanoke County Schools

## Three Year AHERA Reinspection

Back Creek Elementary School  
Facility 011

Reinspection Date:  
March 4, 2008

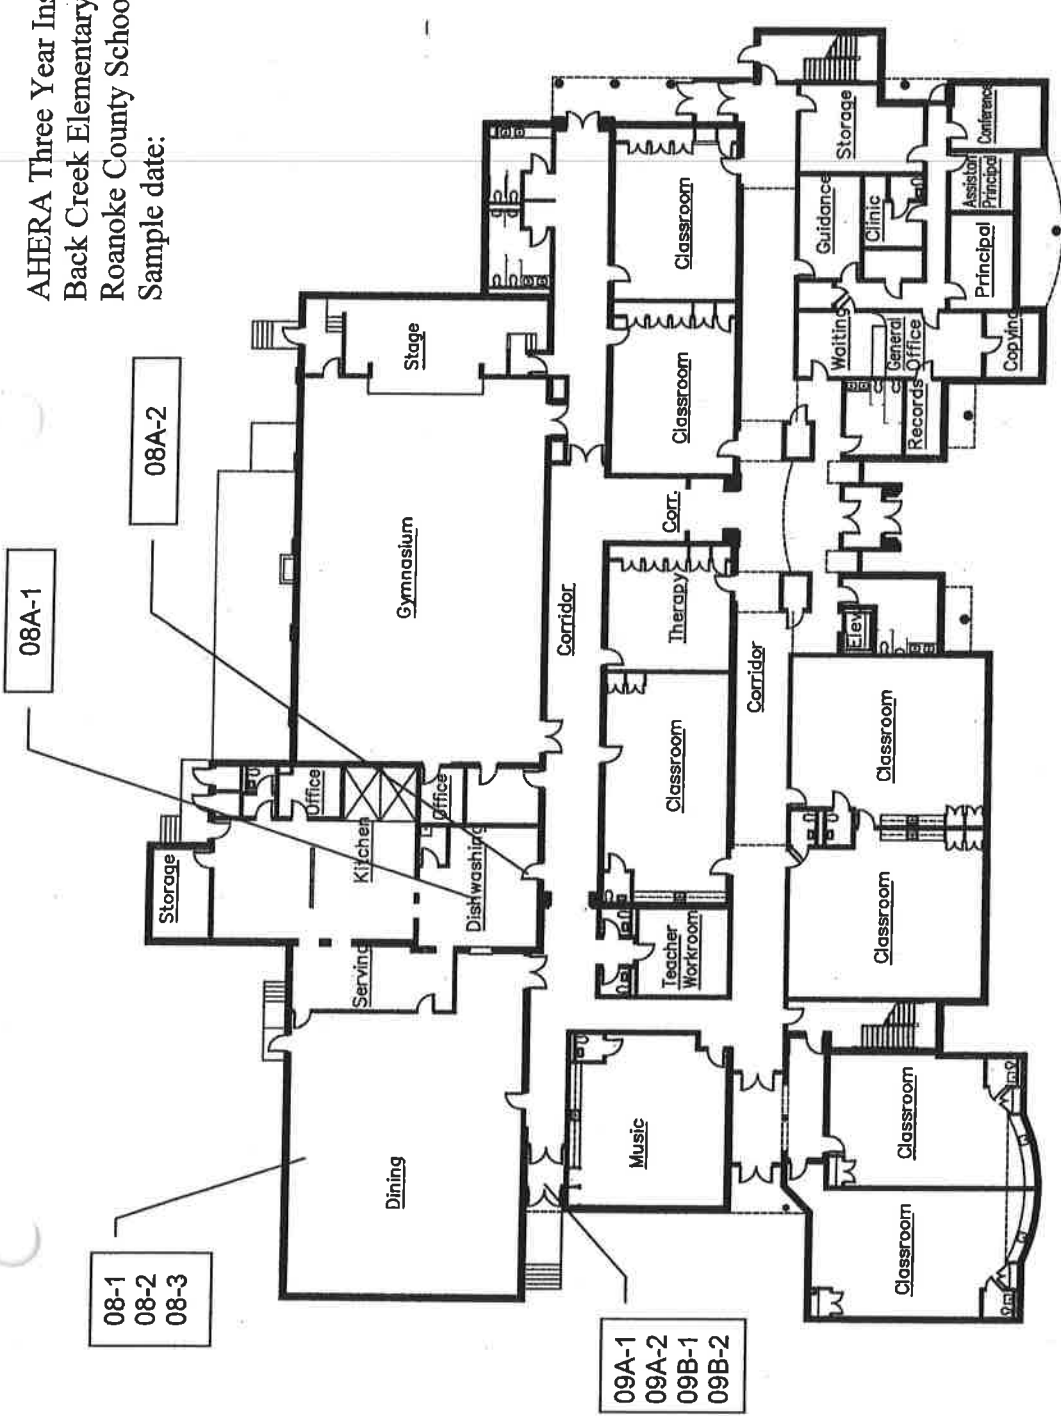
• First Floor Plan

HA-08 LIC 2'x2' random pattern  
 Sample 08-1

HA-08 LIC 2'x2' random pattern (whiter)  
 Sample 08-2

HA-08 LIC 2'x2' approximately  
 Parallel holes  
 Sample 08-3

HA-08A LIC 2'x4' random pattern  
 Sample 08A-1; 08A-2

HA-09A Floor tile 12"x12" light green & white  
 Samples 09A-1; 09A-2

HA-09B Black mastic for HA-09A  
 Samples 09B-1; 09B-2

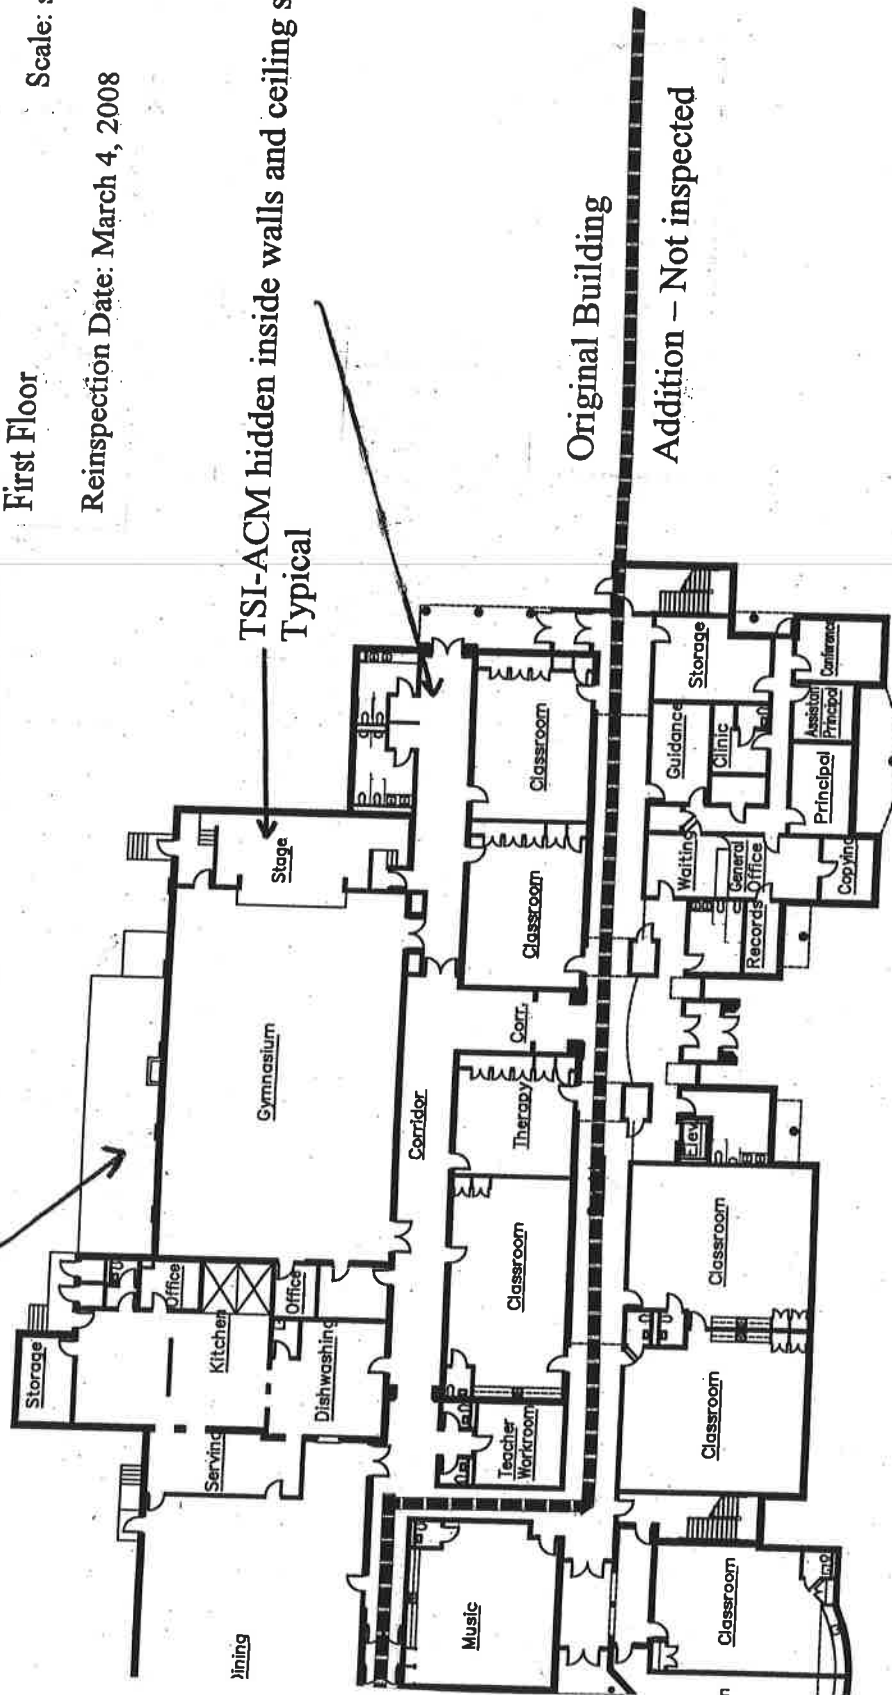
First Floor Plan

No TSI-ACM in Boiler Room or Original Tunnels

TSI-ACM hidden inside walls and ceiling spaces - Typical

The only ACMs that remain in the original building are the TSI hidden in wall and ceiling spaces. These should be removed as they are encountered during or involved in other work.

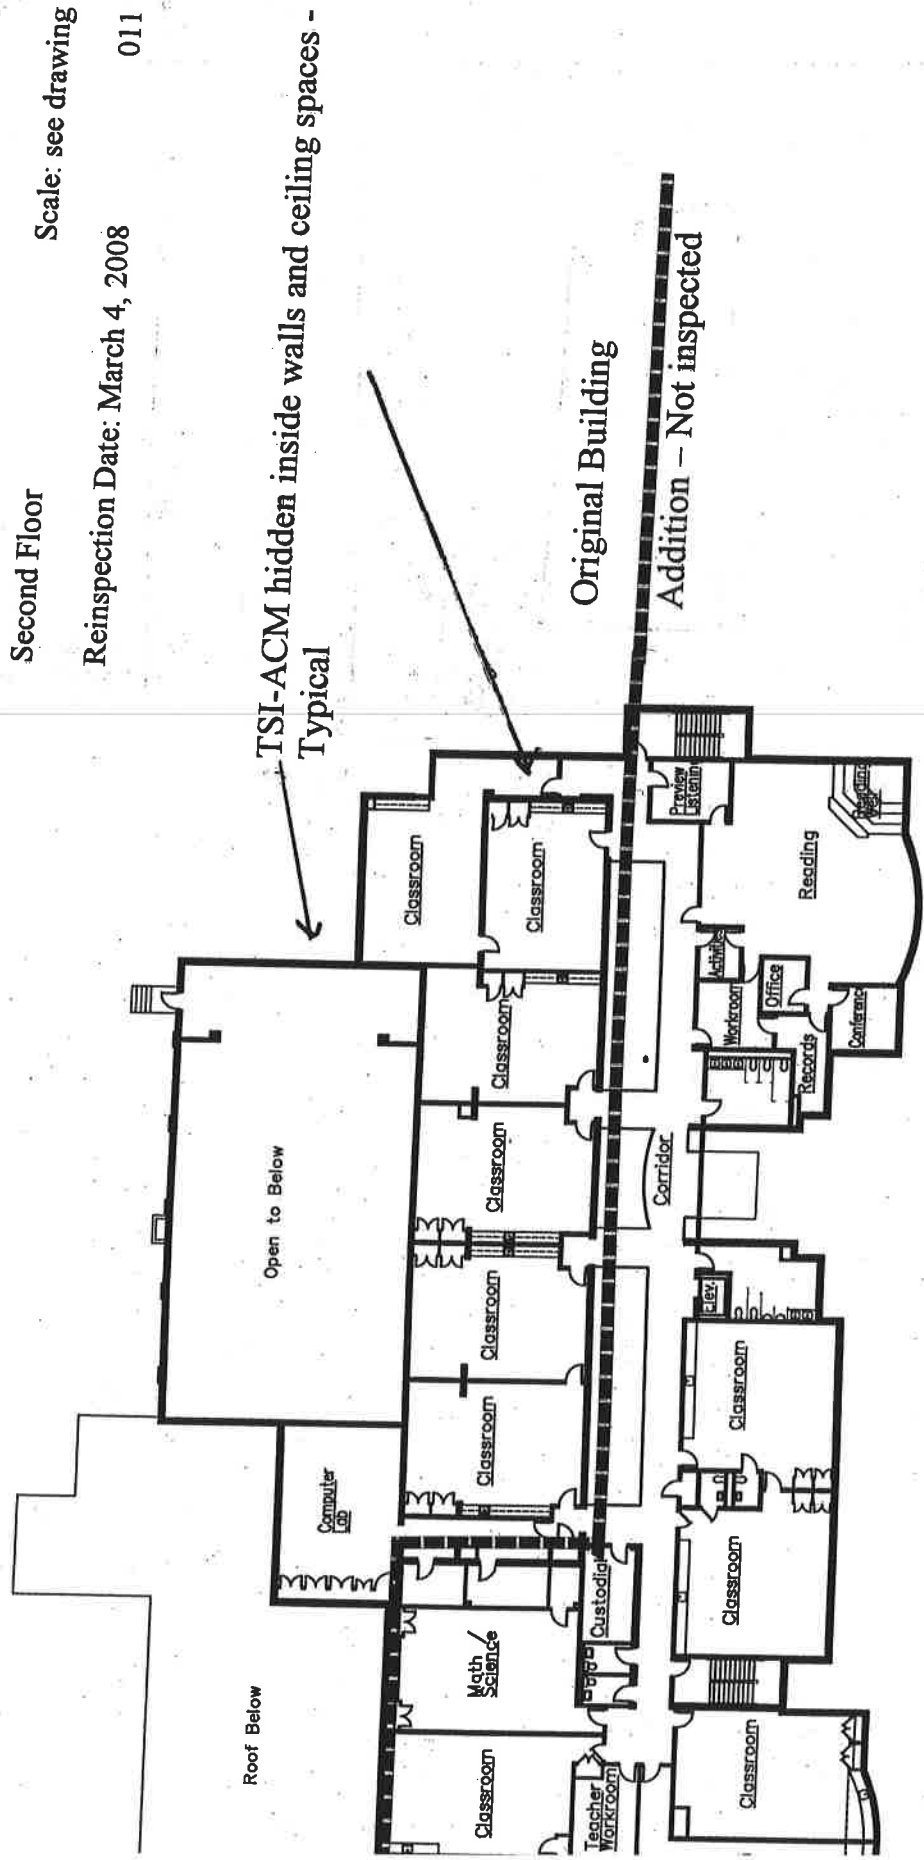
Second Floor Plan

LOCATION OF ACBMs 011 Back Creek E/S  
Second Floor Scale: see drawing  
Reinspection Date: March 4, 2008 011
