# Roanoke County Schools

## Three Year AHERA Reinspection

Cave Spring Elementary School  
Facility 014

Reinspection Date:  
April 8, 2008

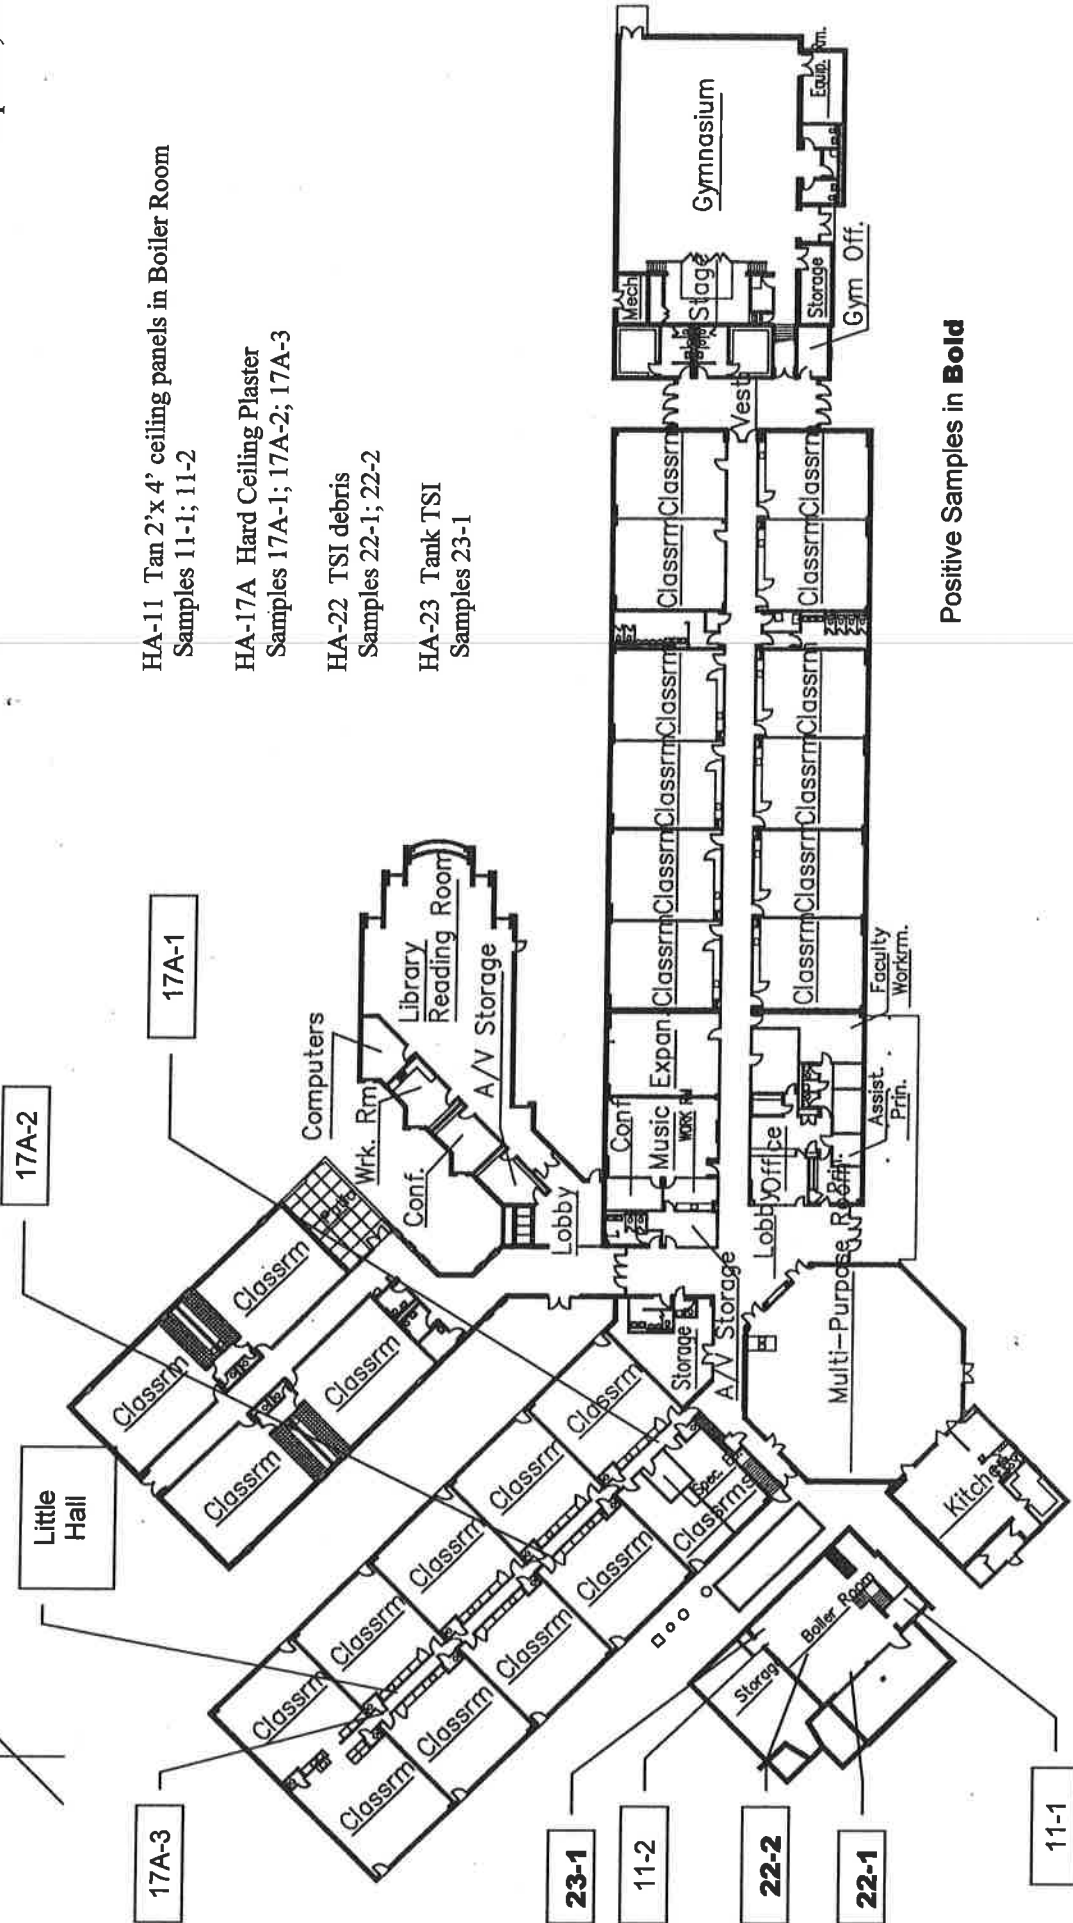
Building 014  
 Sample Locations  
 L001  
 April 8, 2008

HA-11 Tan 2'x 4' ceiling panels in Boiler Room  
 Samples 11-1; 11-2

HA-17A Hard Ceiling Plaster  
 Samples 17A-1; 17A-2; 17A-3

HA-22 TSI debris  
 Samples 22-1; 22-2

HA-23 Tank TSI  
 Samples 23-1

Positive Samples in **Bold**
