# Roanoke County Schools

## Three Year AHERA Reinspection

Cave Spring Middle School  
Facility 006

February 15, 2008

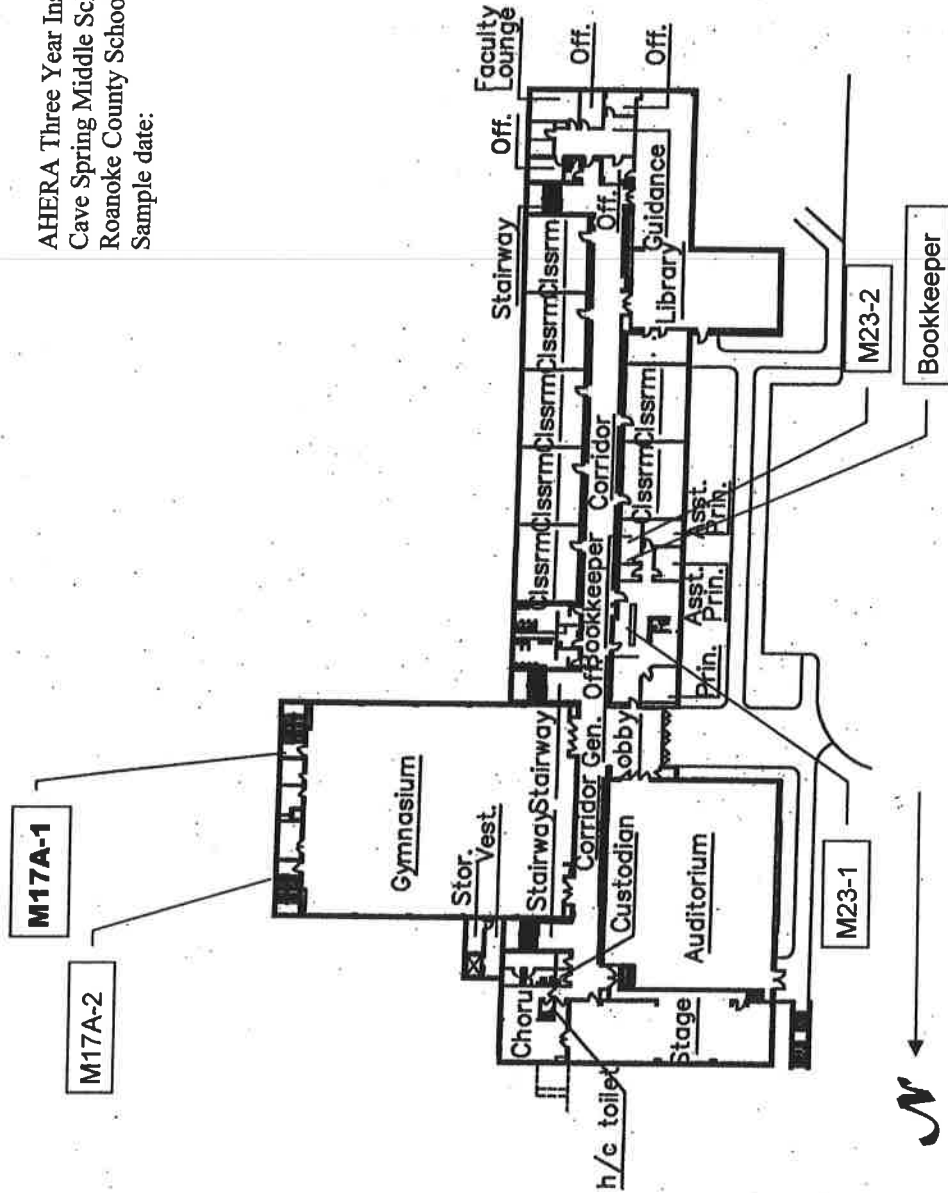
Main Building 001  
 Sample Locations  
 L001

HA M17A Brown Mastic for ACT 12" x 12" (HA-17)  
 Samples M17A-1, M17A-2

HA M23 LIC 2'x 2' random  
 Samples M23-1, M23-2

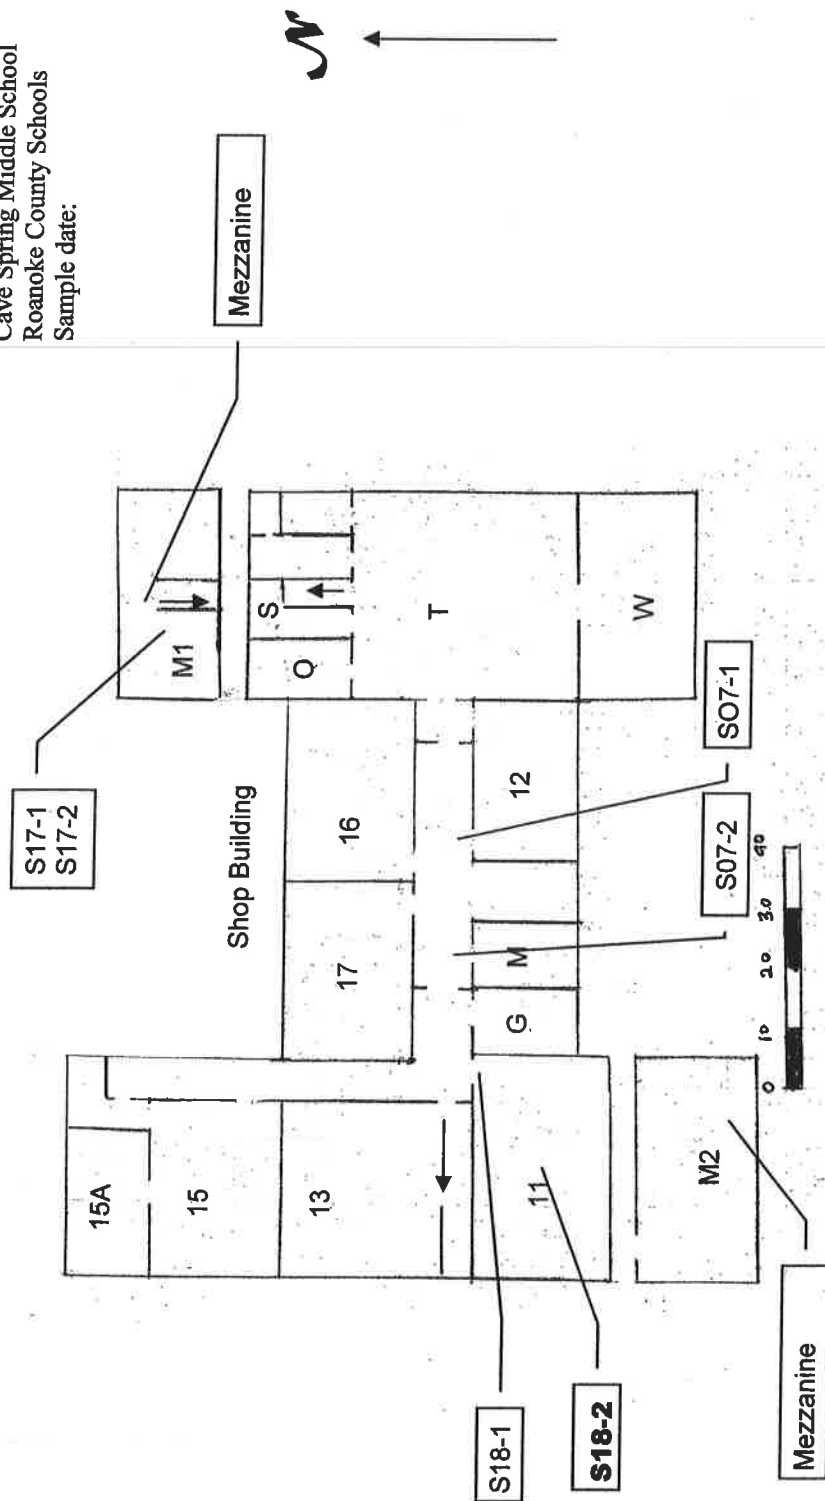
Shop Building  
 Sample Location  
 L001  
 February 15, 2008

HA-S18 LIC 2'x2' perforated, parallel holes  
 Samples S18-1, S18-2

HA-S07 LIC 2'x2' parallel holes  
 Samples S07-1, S07-2

HA-S17 Sheet vinyl, beige  
 Samples S17-1, S17-2

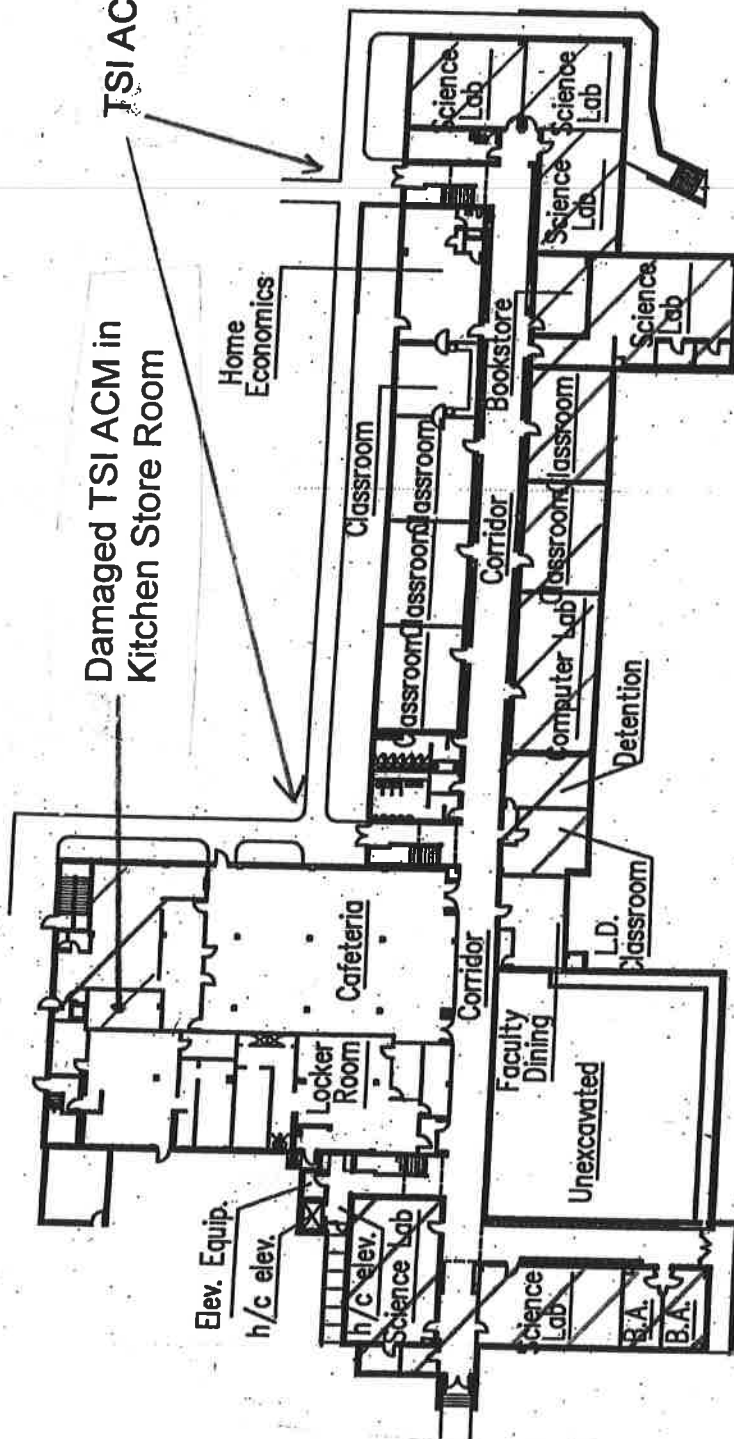
Lower Floor

Boiler TSI in Boiler Room  
(other TSI-ACM had been removed from boiler room)

Damaged TSI ACM in Kitchen Store Room

TSI ACM typical through out building

Each Location	Recommended Response Actions	Scheduled To Begin	Scheduled To Be Completed	Est. Cost To Remove
TSI in Kitchen Storage Room	Removed damaged TSI	April 2008	May 2008	\$2,000
TSI in Boiler Room and through out building	Repair damaged TSI. Place in O & M plan until other needs require the TSI be removed	none	none	60,000
Boiler TSI	Place in O & M plan until other needs require the TSI be removed	none	none	20,000
Acoustical Ceiling Tile Mastic in Stairwells	Place in O & M Plan until removed	none	none	4,000
Floor tile in various Rooms <sup>1</sup>	Maintain floor coverings until other needs require these floor coverings to be removed	none	none	\$30,000

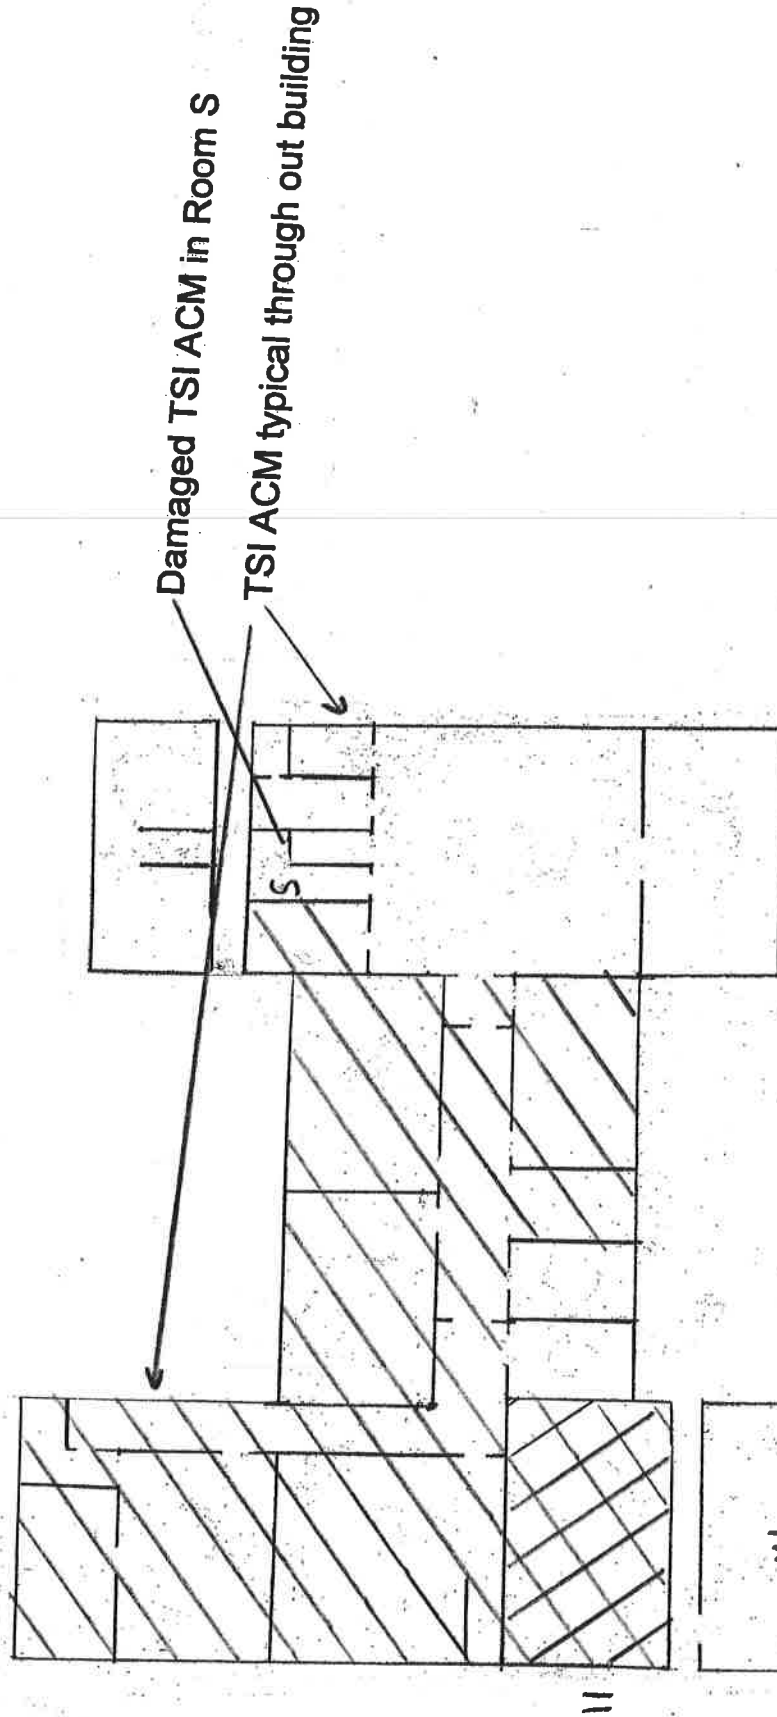
Shop Building

Asbestos containing floor tiles
	Asbestos containing lay in ceiling panels

Each Location	Recommended Response Actions	Scheduled To Begin	Scheduled To Be Completed	Est. Cost To Remove
TSI in Room S (HA-08)	Removed damaged TSI on pipe riser	March 2008	April 2008	\$2,000
TSI in Mezzanine M2 above Room 11 (HA-01 & 02)	Removed roof drain TSI	Summer 2008	Summer 2008	\$5,000
TSI through out building	Repair damaged TSI. Place in O & M plan until other needs require the TSI be removed	none	none	15,000
LIC in Room 11 (HA-18)	Removed lay-in ceiling tiles	Summer 2008	Summer 2008	\$3,000
Floor tile in various Rooms <sup>1</sup>	Maintain floor coverings until other needs require these floor coverings to be removed	none	none	\$13,000
