Roanoke County Schools

Three Year AHERA Reinspection

Glenvar High School
Facility 003

Reinspection Date:
February 12, 2008

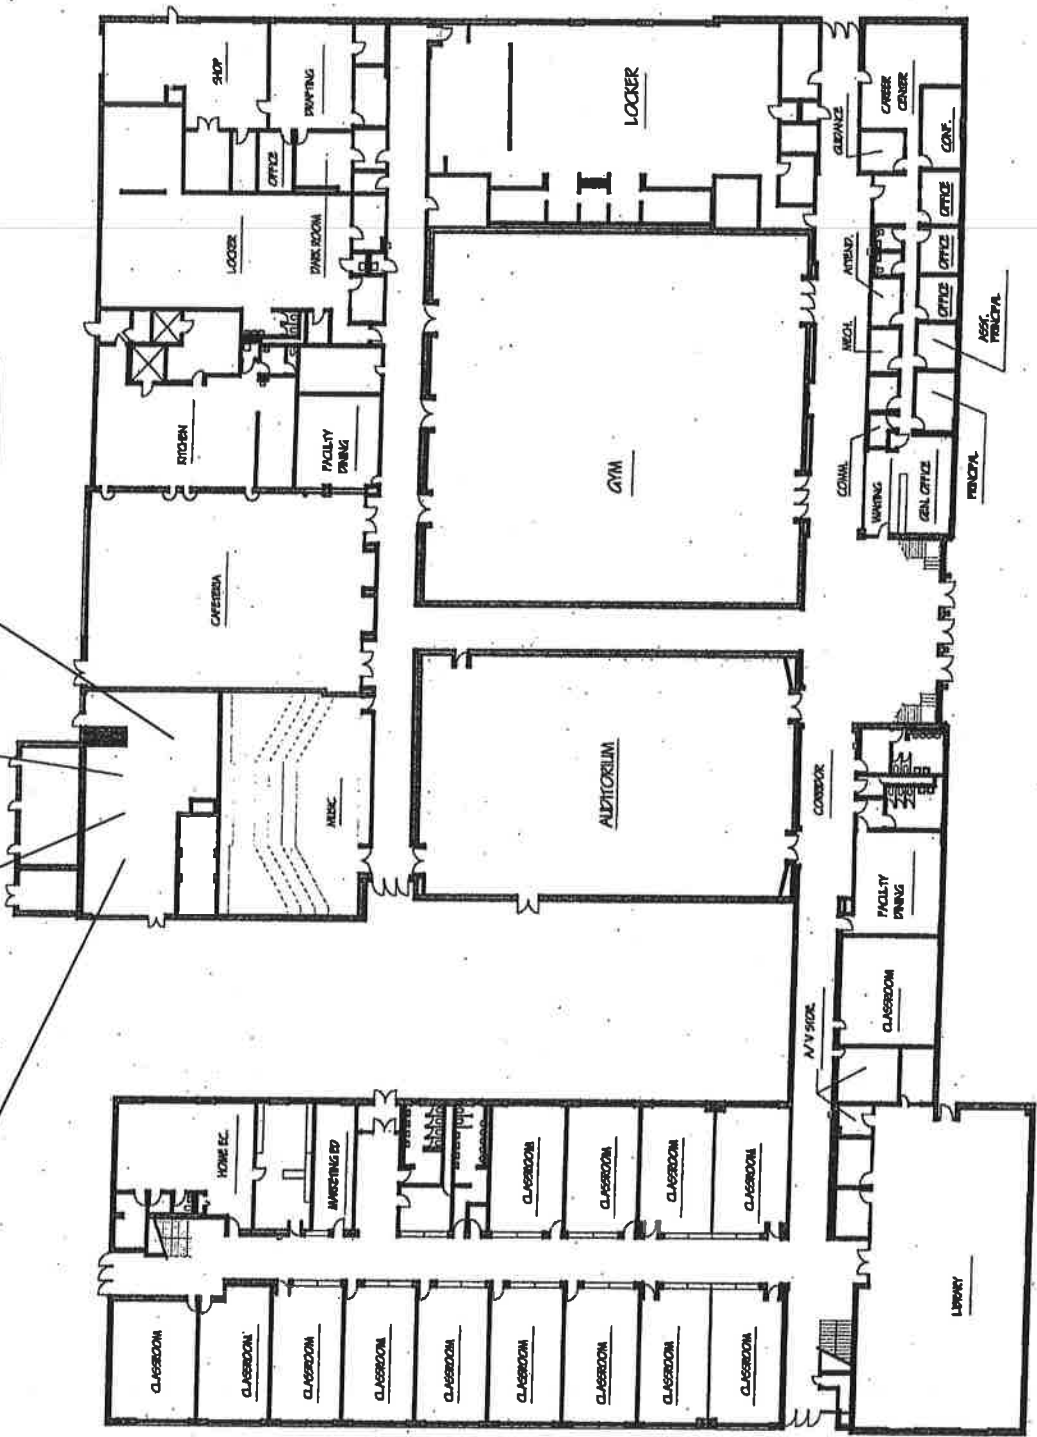
First or
 Sample Locations
 L001
 February 12, 2008

Boiler Room

HA-06 Boiler TSI
 Samples 06-1, 06-2, 06-3

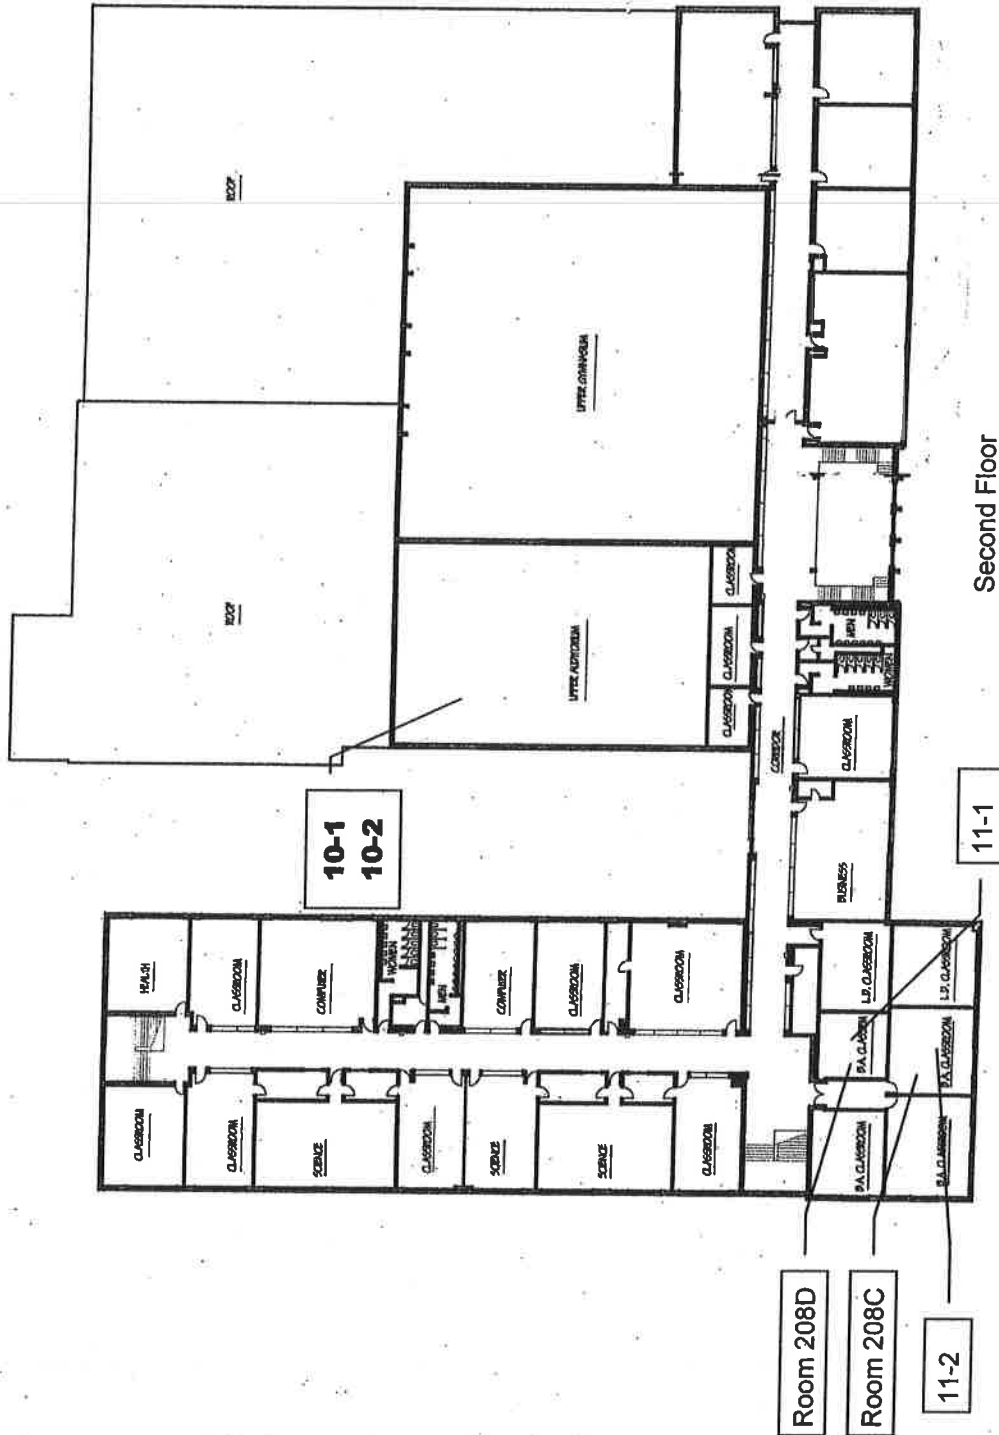
Second Floor
 Sample Locations
 L001
 February 12, 2008

HA-10 Floor light wire insulation
 Samples 10-1, 10-2

HA 11 LIC 2'x2', random pattern
 Samples 11-1, 11-2

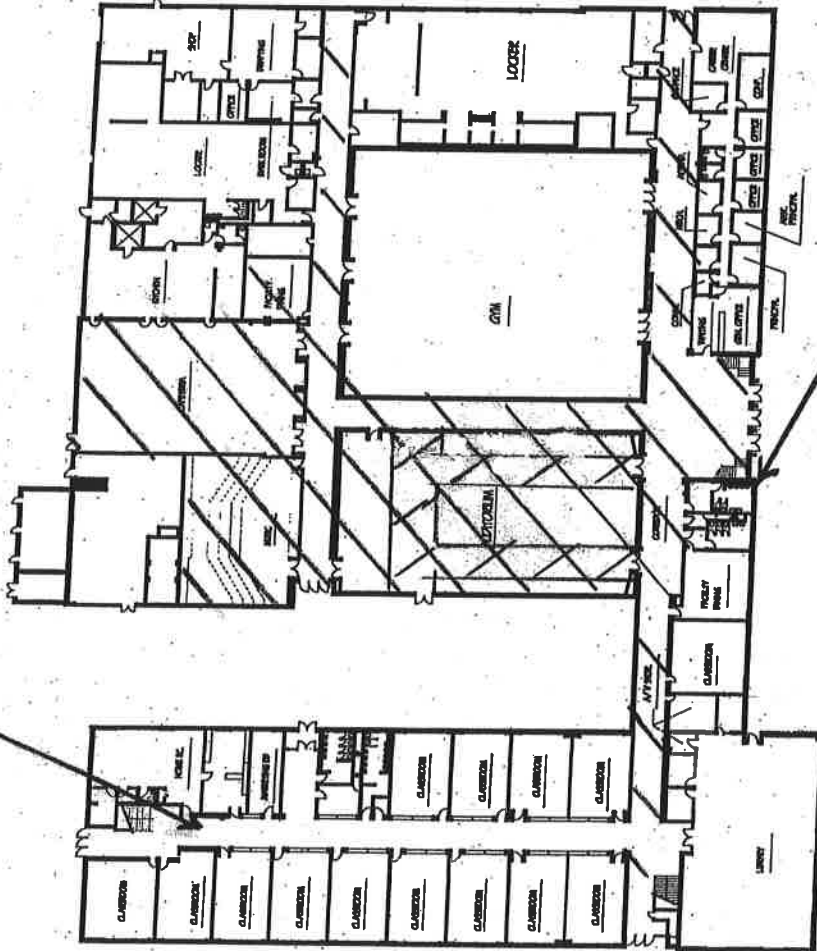
First Floor

Asbestos containing ceiling plaster removed from this hall in Summer of 1999

Asbestos containing fitting muds in bathroom chases - Typical

Asbestos containing ceiling plaster enclosed with gypsumboard covering.
	Asbestos containing TSI on Fittings, Tank Number1 and Breeching
	Asbestos containing floor tiles under carpeting
	Asbestos containing insulation of stage lighting

Damaged fitting muds were observed in the bathroom chases. Access to these chases should be limited until the damaged fitting TSIs are abated.

Damaged fitting muds were noted in the chases between the bathrooms. The chase accesses should be sealed. An asbestos warning sign should be placed on the door until the damaged fittings are removed.

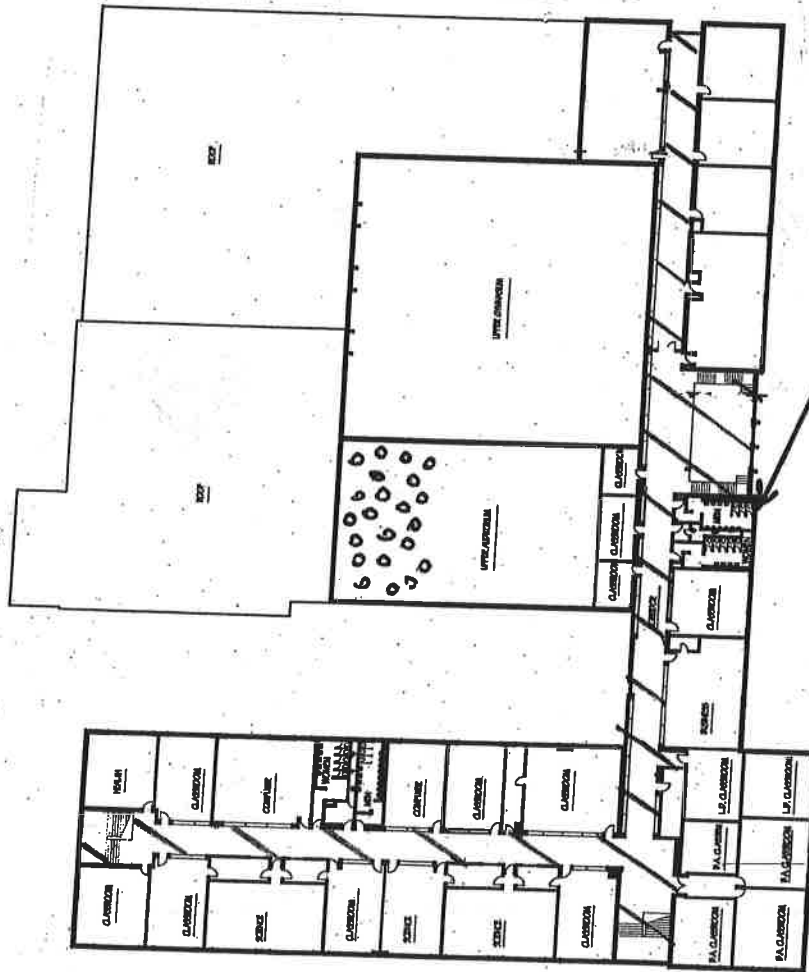
Second floor

Asbestos containing ceiling plaster enclosed with gypsumboard covering.
	Asbestos containing TSI on Fittings, Tank Number1 and Breeching
	Asbestos containing floor tiles under carpeting
	Asbestos containing insulation of stage lighting

Asbestos containing fitting muds in bathroom chases - Typical
