Roanoke County Schools

Three Year AHERA Reinspection

Green Valley Elementary School
Facility 019

Reinspection Dates:

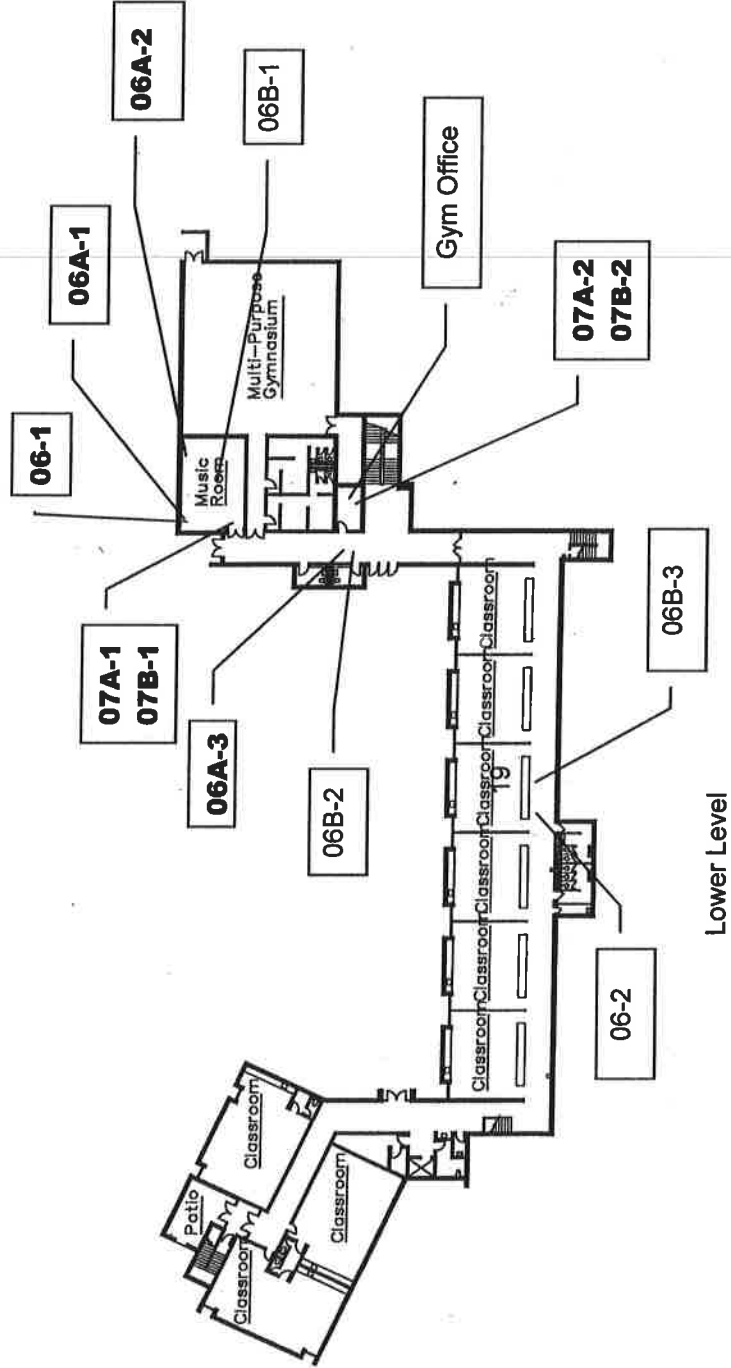
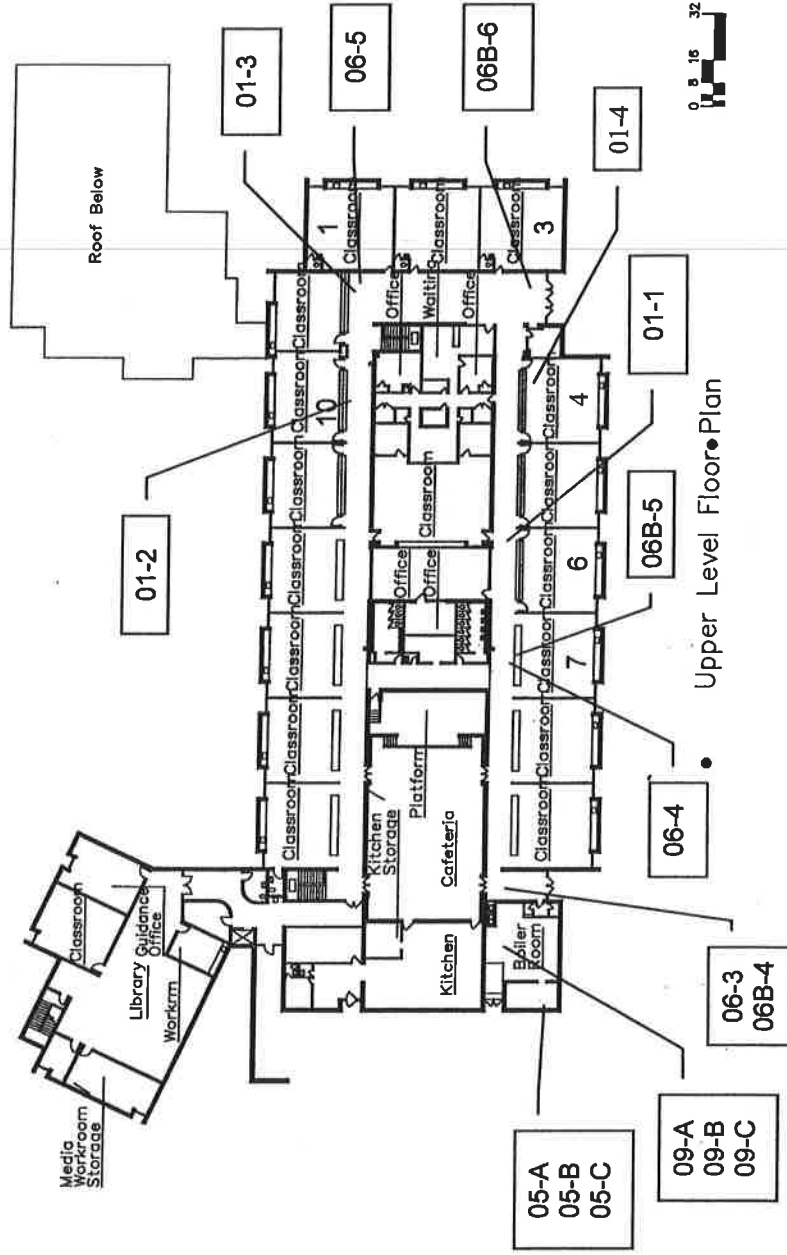
Building 019
Sample Locations
L001
May 6, 2008
June 24, 2008

- HA-06 LIC 2'x2'; parallel long holes
 Samples 06-1; 06-2
- HA-06A LIC 2'x2'; Type 1, parallel long hole, grey back with "install arrow"
 Samples 06A-1; 06A-2; 06A-3;
- HA-06B LIC 2'x2'; Type II parallel long, tan back
 Samples 06B-1, 06B-2, 06B-3
- HA-07A Floor tile 9"x9", white with tan streaks
 Samples 07A-1; 07A-2
- HA-07B Black mastic for HA-07A
 Samples 07B-1; 07B-2

HA-01 Gypsum board System
Samples 01-1; 01-2; -01-3; 01-4

HA-05 Roof drain fitting TSI
Samples 05-A; 05-B; 05-C

HA-06 LIC 2'x2', long holes parallel to short side
Samples 06-3, 06-4; 06-5

HA-06B LIC 2'x2', Type II long holes parallel to short side, tan back
Samples 06B-4; 06B-5; 06B-6

HA-09 Breaching TSI
Samples 09A; 09B; 09C

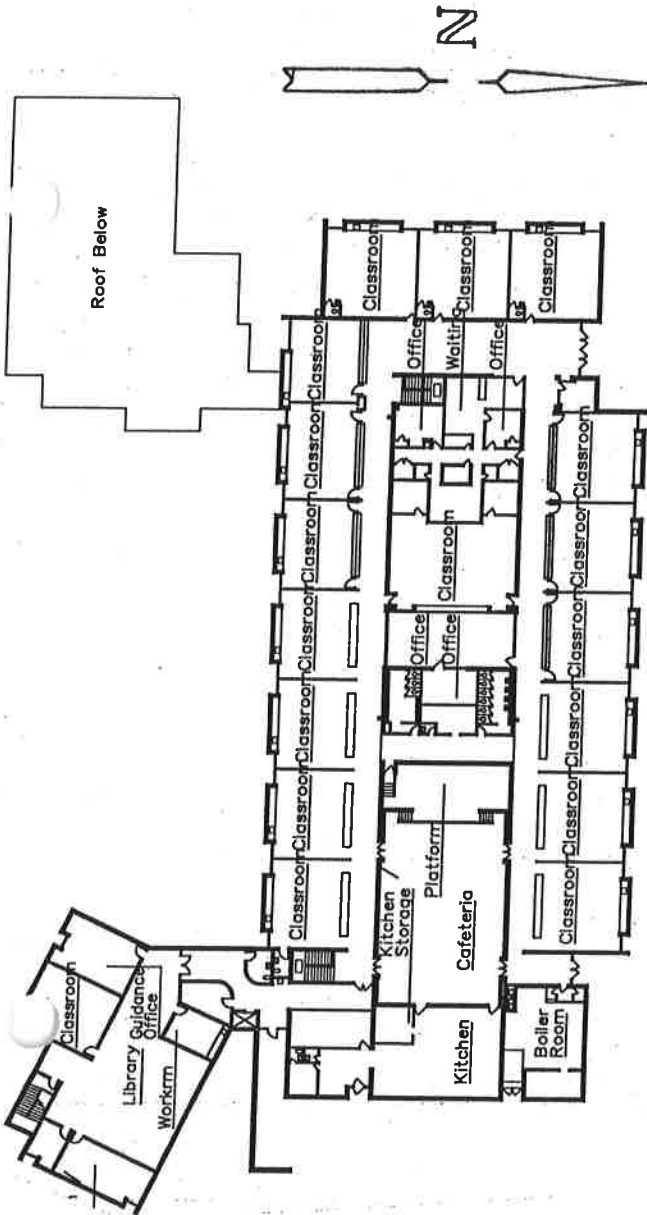
Upper Level Floor Plan

Asbestos containing LIC panels HA-06A (see note)

Asbestos containing floor tiles and mastics - HA 07A & 07B

LIC Note Asbestos containing LIC 2' x 2' Type I panels have parallel long holes and a grey back with "install arrow" printed on it. These are mixed with other non - ACM LICs. We believe the Type I LICs only exist in the area shown. This should be confirmed by the asbestos removal designer.

TSI-ACM may be hidden inside walls and ceiling spaces - Typical

Each Location	Recommended Response Actions	Scheduled To Begin	Scheduled To Be Completed	Est. Cost To Remove
LIC 2' x 2' Type I, parallel long holes, grey back with "install arrow" (06A) *	Place in O & M Plan until removed	none	none	\$20,000
Floor tile and mastic (07A & 07)B	Place in O & M Plan until removed	none	none	\$3,000

* Numerous lay-in ceiling panels exist in this building. The asbestos containing LICs appear to exist only on the lower level and then only in the wing that houses the Music Room and Gymnasium. They are mixed with other salient LIC panels. Their extent should be confirmed prior to any abatement.
