# Roanoke County Schools

## Three Year AHERA Reinspection

Mount Pleasant Elementary School  
Facility 023

June 10, 2008

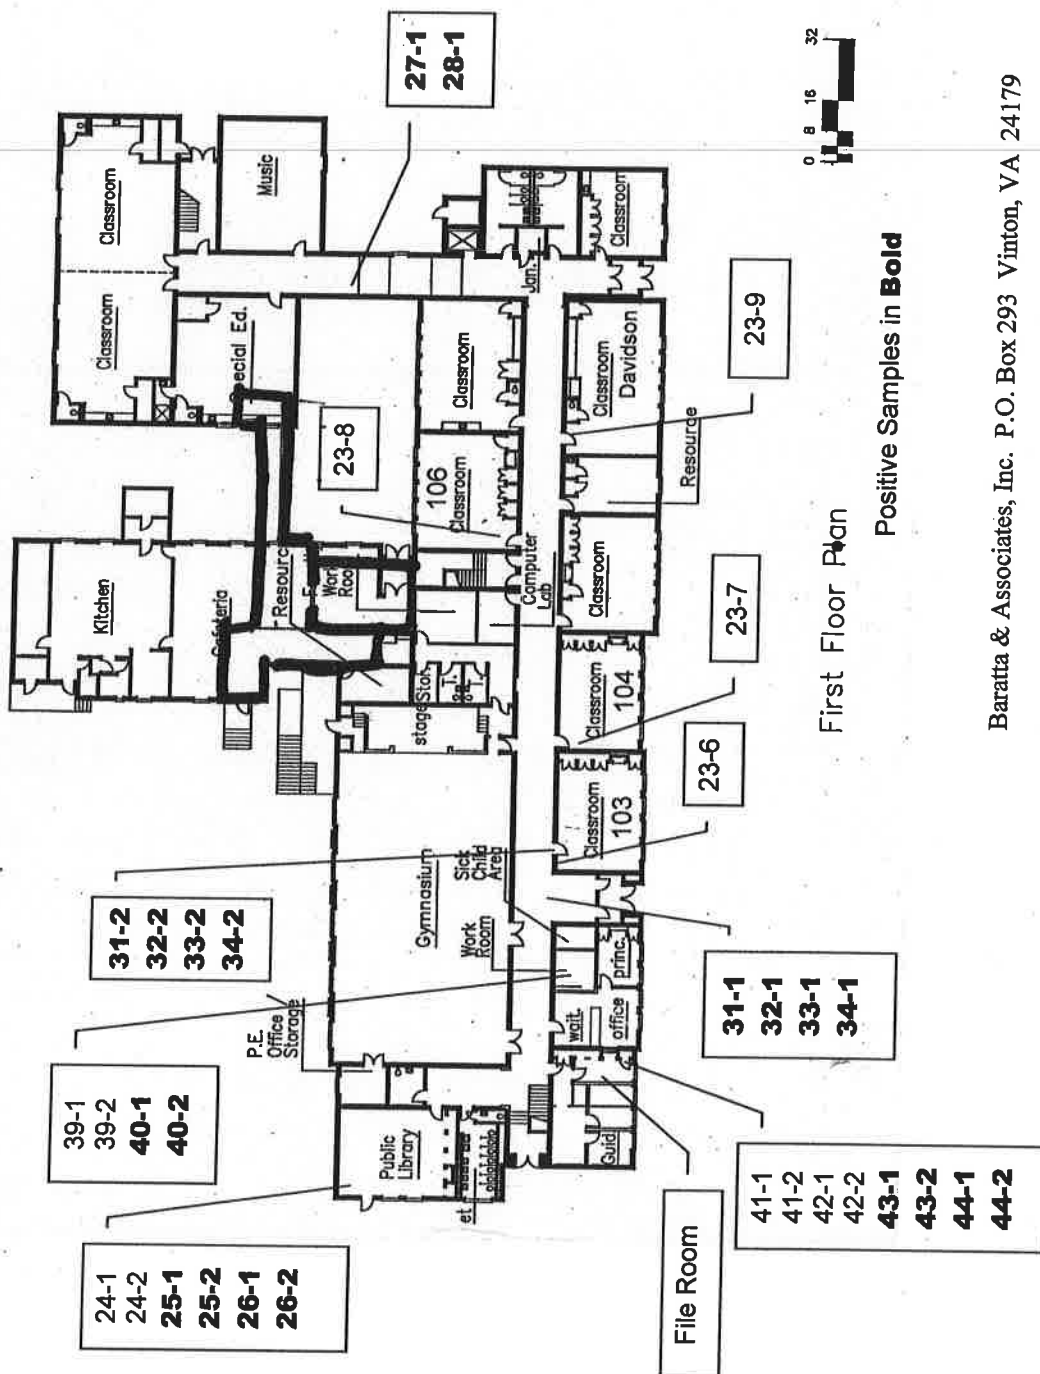
AHERA Three Year Inspection  
 Mount Pleasant Elementary School  
 Roanoke County Schools  
 Sample dates:  
 Building 023  
 Sample Locations  
 L002  
 June 10, 2008

HA-23 Plaster  
 Samples ; 23-6; 23-7; 23-8; 23-9  
 HA-24 Tan mastic for blue carpet  
 Samples 24-1; 24-2

HA-25 Floor tile 12"x12" white under HA-24  
 Samples 25-1; 25-2

HA-26 Black mastic for HA-23  
 Samples 26-1; 26-2

HA-27 Floor tile 12"x12" tan w/ brown & white  
 Samples 27-1

HA-28 Black mastic for HA-27  
 Samples 28-1

HA-31 Floor tile 12"x12" white 2/ grey streaks  
 Samples 31-1; 31-2

HA-32 Black mastic for HA-31  
 Samples 32-1; 32-2

HA-33 Brown floor tile under HA-31  
 Samples 33-1; 33-2

HA-34 Black mastic for HA-33  
 Samples 34-1; 34-2

HA-39 Floor tile 12"x12" white w/ cream  
 Samples 39-1; 39-2

HA-40 Black mastic for HA-39  
 Samples 40-1; 40-2

HA-41 Floor tile 12"x12", white w/ taupe  
 Samples 41-1; 41-2

HA-42 Brown mastic for HA-41  
 Samples 42-1; 42-2

HA-43 White floor tile under HA-41  
 Samples 43-1; 43-2

HA-44 Black mastic for HA-43  
 Samples 44-1; 44-2

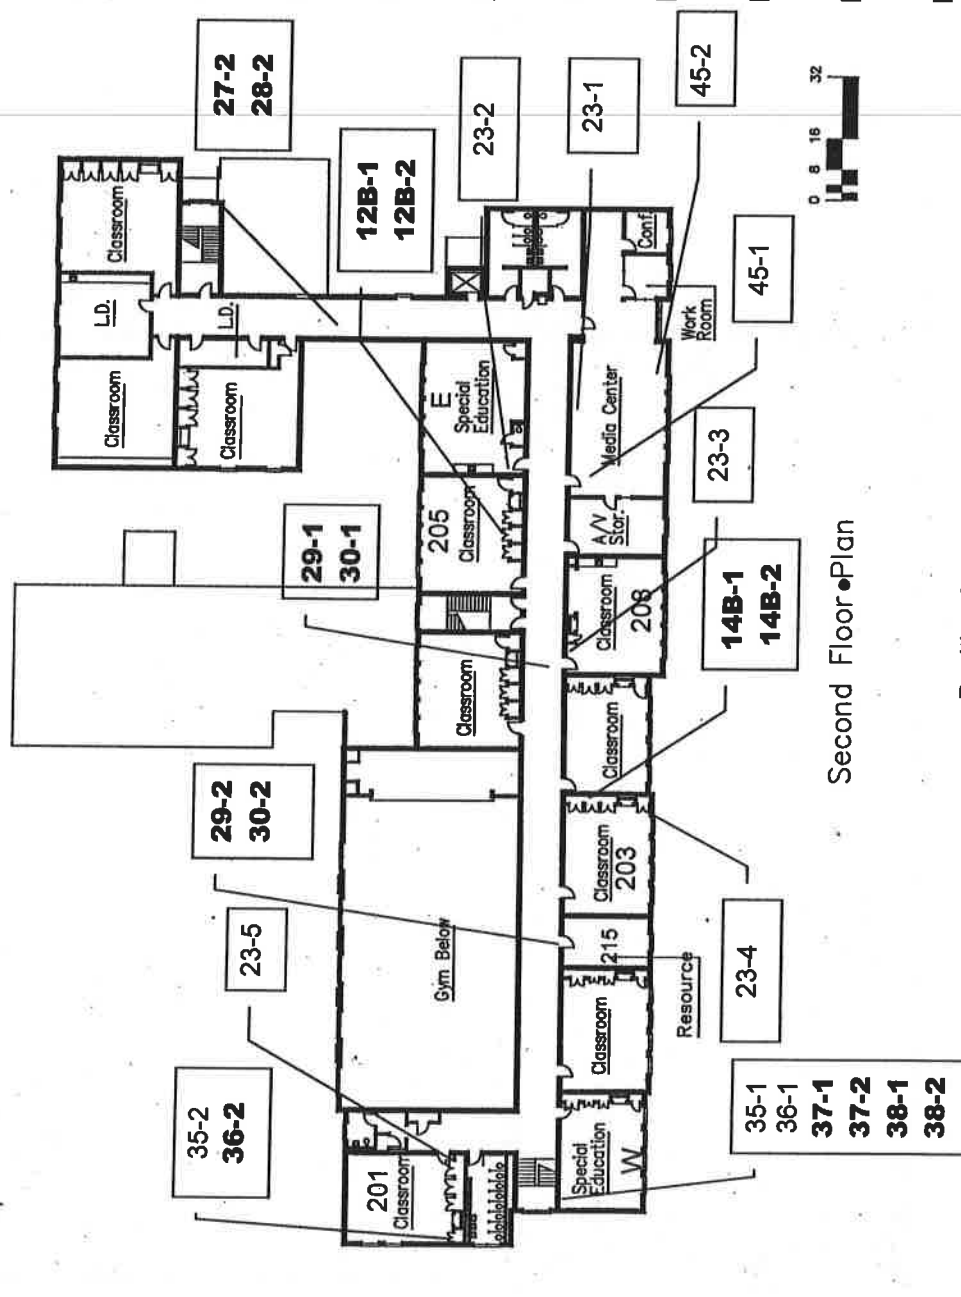
Building 023  
 Sample Locations  
 L001  
 June 10, 2008

- HA-12B Black mastic for brown 9"x9" HA-12A  
 Samples 12B-1; 12B-2  
 HA-14B Black mastic for tan 9"x9" floor tile  
 HA-14A  
 Samples 14B-1; 14B-2  
 HA-23 Plaster  
 Samples 23-1; 23-2; 23-3; 23-4; 23-5  
 HA-27 Floor tile 12"x12", tan w/ brown & white  
 Samples 27-2  
 HA-28 Black mastic for HA-27  
 Samples 28-2  
 HA-29 Floor tile 12"x12", cream w/ almond  
 Sample 29-1; 29-2  
 HA-30 Black mastic for HA-29  
 Sample 30-1; 30-2  
 HA-35 Floor tile 12"x12" grey w/ white & blue  
 Samples 35-1; 35-2  
 HA-36 Tan mastic for HA-35  
 Samples 36-1; 36-2  
 HA-37 Black floor tile under HA-35 in Spec. Ed.  
 Samples 37-1; 37-2  
 HA-38 Black mastic for HA-37  
 Samples 38-1; 38-2  
 HA-45 ACT 12"x12"  
 Samples 45-1; 45-2

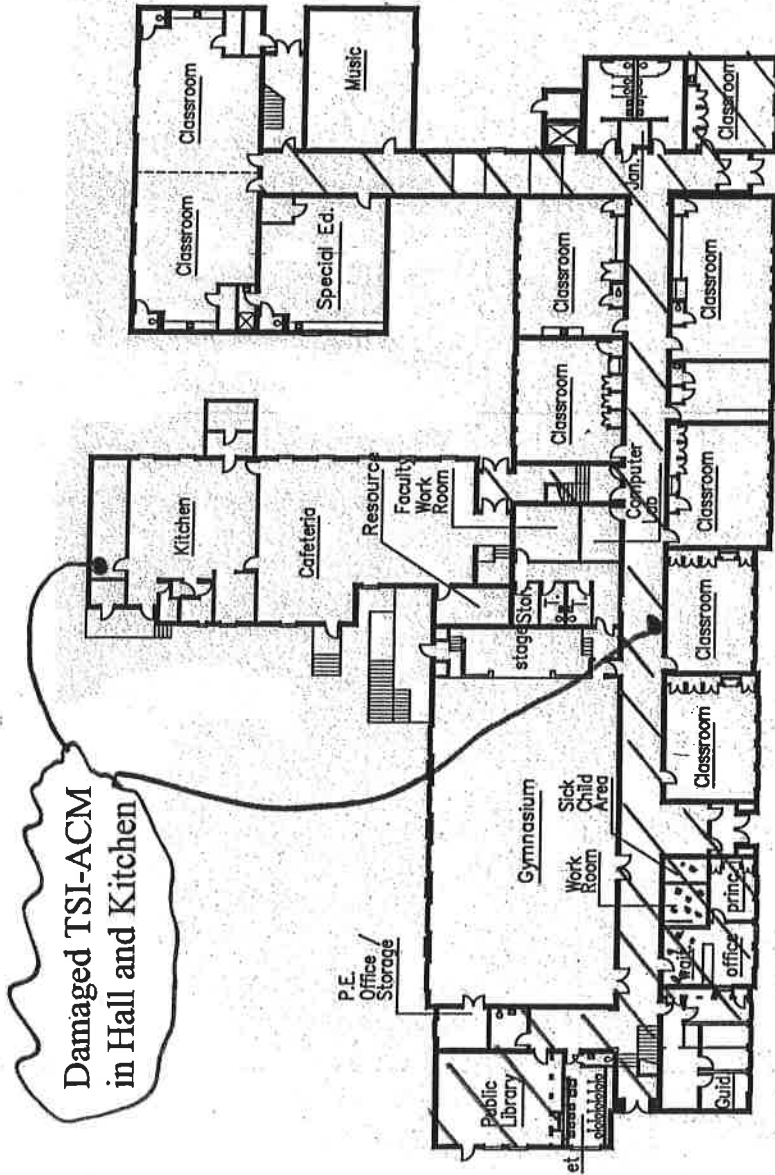
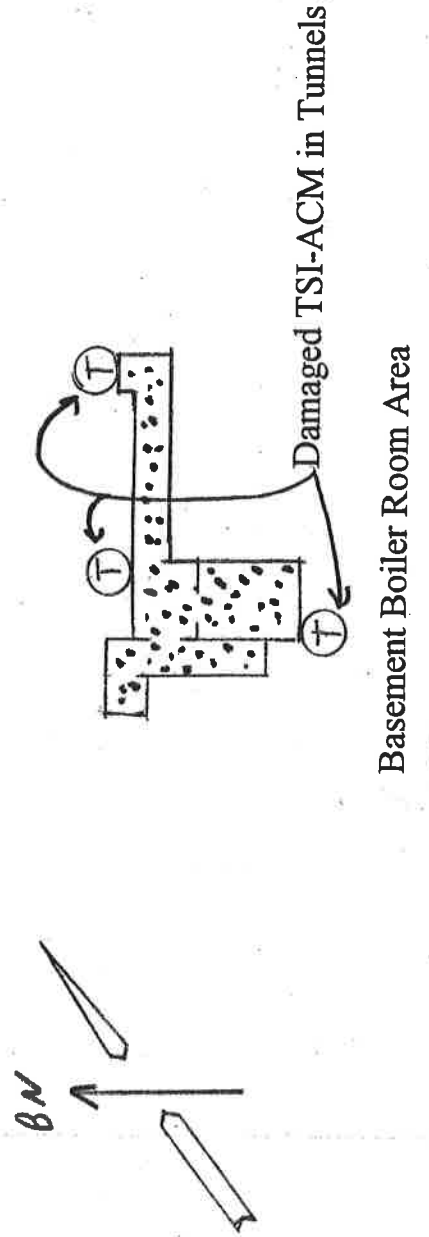
First Floor Scale: see drawing

Asbestos containing floor tiles and mastics
	Asbestos containing floor tile mastics (tiles are non-ACMs)
	TSI-ACM in Basement

TSI-ACM hidden inside walls and ceiling spaces - Typical

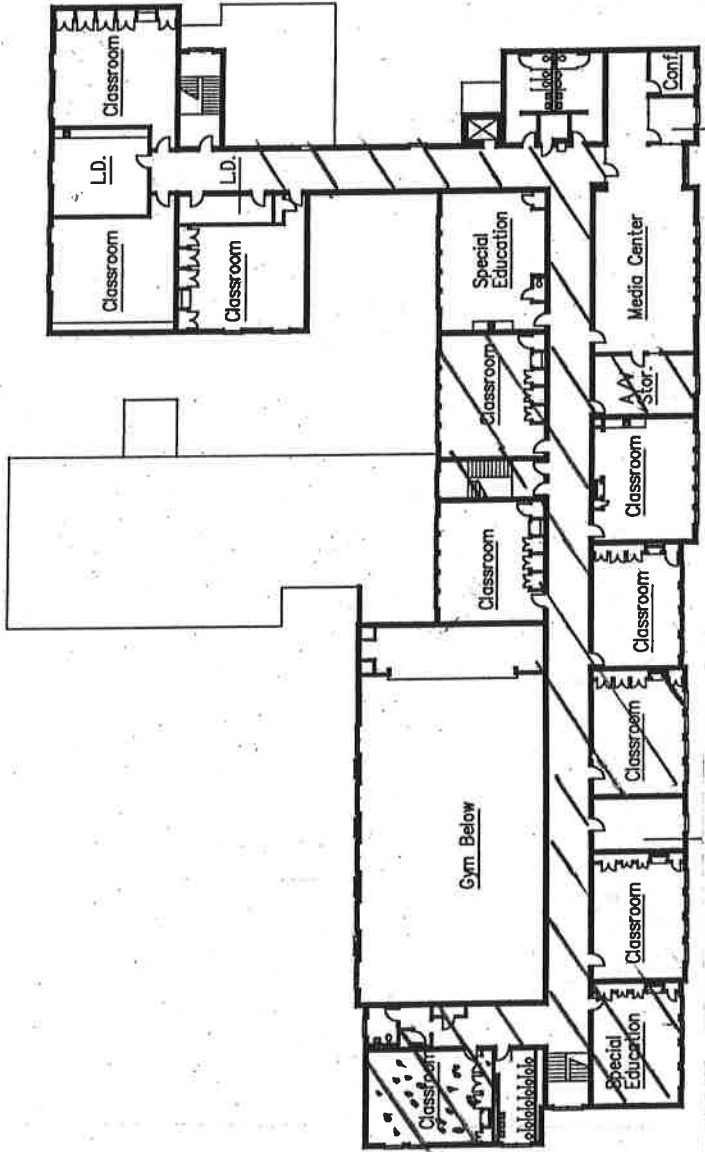
Second Floor

Asbestos containing floor tiles and mastics
	Asbestos containing floor tile mastics (tiles are non-ACMs)

TSI-ACM hidden inside walls and ceiling spaces - Typical
