Roanoke County Schools

Three Year AHERA Reinspection

Mountain View Elementary School
Facility 024

June 17, 2008

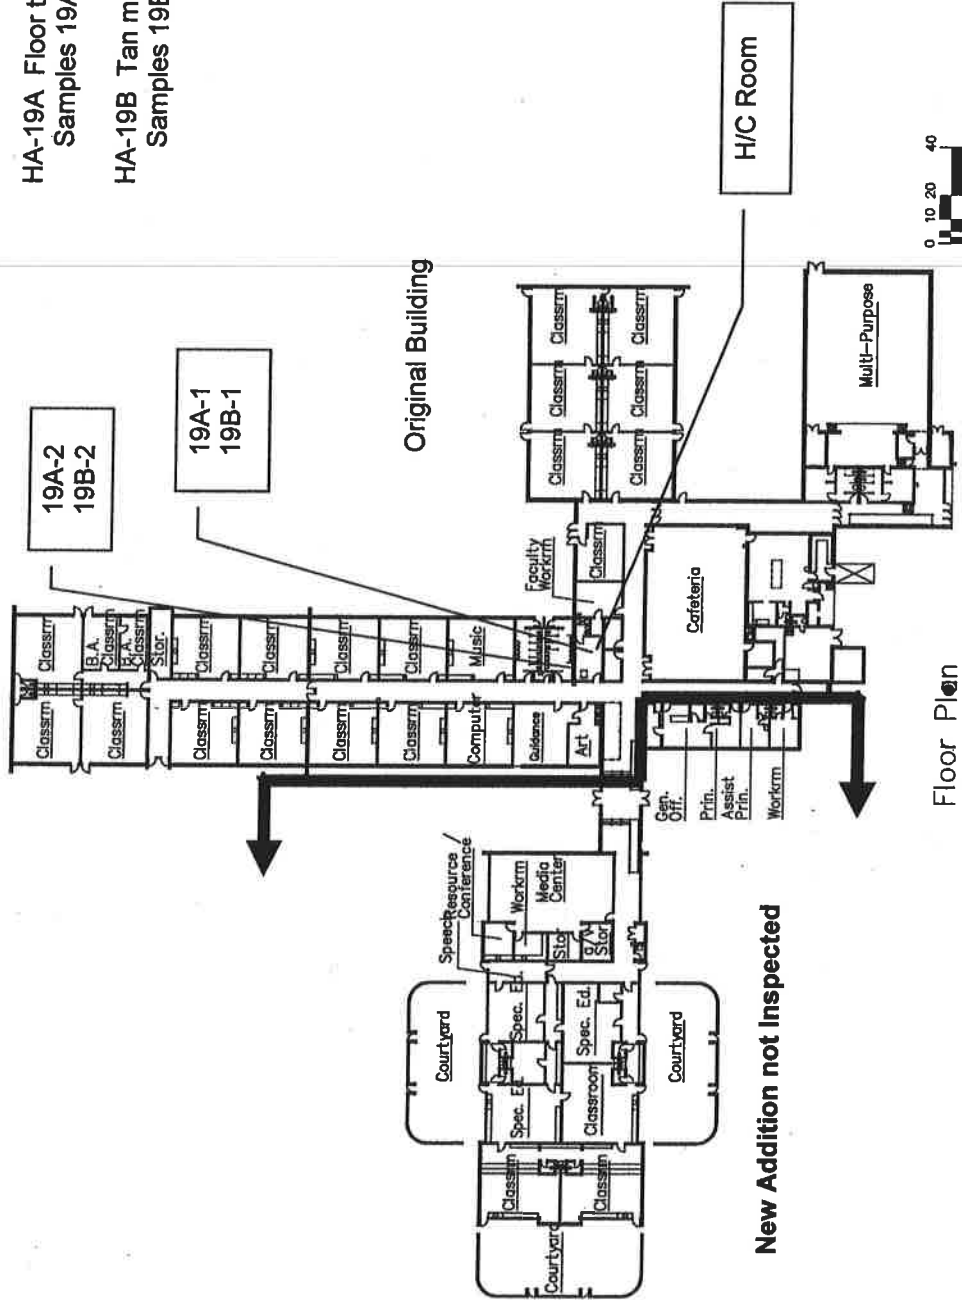
AHERA Three Year Inspection
 Mt. View Elementary School
 Roanoke County Schools
 Sample dates:
 Building 024
 Sample Locations
 L002
 June 17, 2008

All previously identified asbestos containing floor tiles and other materials had been removed. One suspect floor tile was noted in the H/C room. This was similar to HA-19 in the H-K Report. We subdivided this floor covering into its tile (19A) and mastic (19B) fractions and obtained two (2) samples each.

HA-19A Floor tile 12" x 12" white w/ grey spots
 Samples 19A-1; 19A-2
 HA-19B Tan mastic for HA-19A
 Samples 19B-1; 19B-2
