# Roanoke County Schools

## Three Year AHERA Reinspection

### Northside Middle School Facility 008

Reinspection Date: January 23, 2008

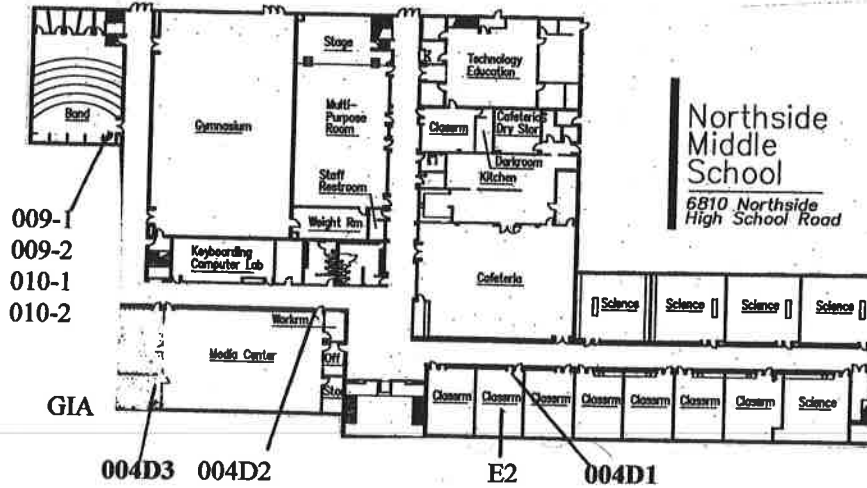
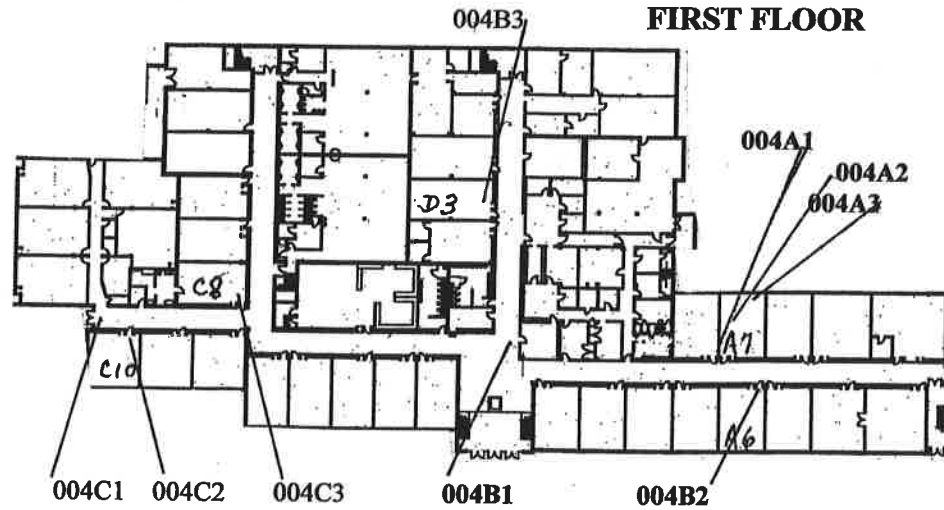
AHERA Three Year Inspection Building 008  
 Northside Middle School Sample Locations  
 Client: Roanoke County Schools L001  
 Sample date: January 23, 2008 Scale: none

004A LIC holes parallel to short side in Room A7  
 Samples 004A1, 004A2, 004A3

009 ACT, 12"x12" perforated  
 Samples 009-1, 009-2

004B LIC holes parallel to short side on First Floor  
 Samples 004B1, 004B2 and 004B3

010 Mastic for 009, tan  
 Samples 010-1, 010-2

004C LIC random pattern on First Floor  
 Samples 004C1, 004C2, and 004C3

004D LIC parallel to short side on Second Floor  
 Samples 004D1, 004D2 and 004D3

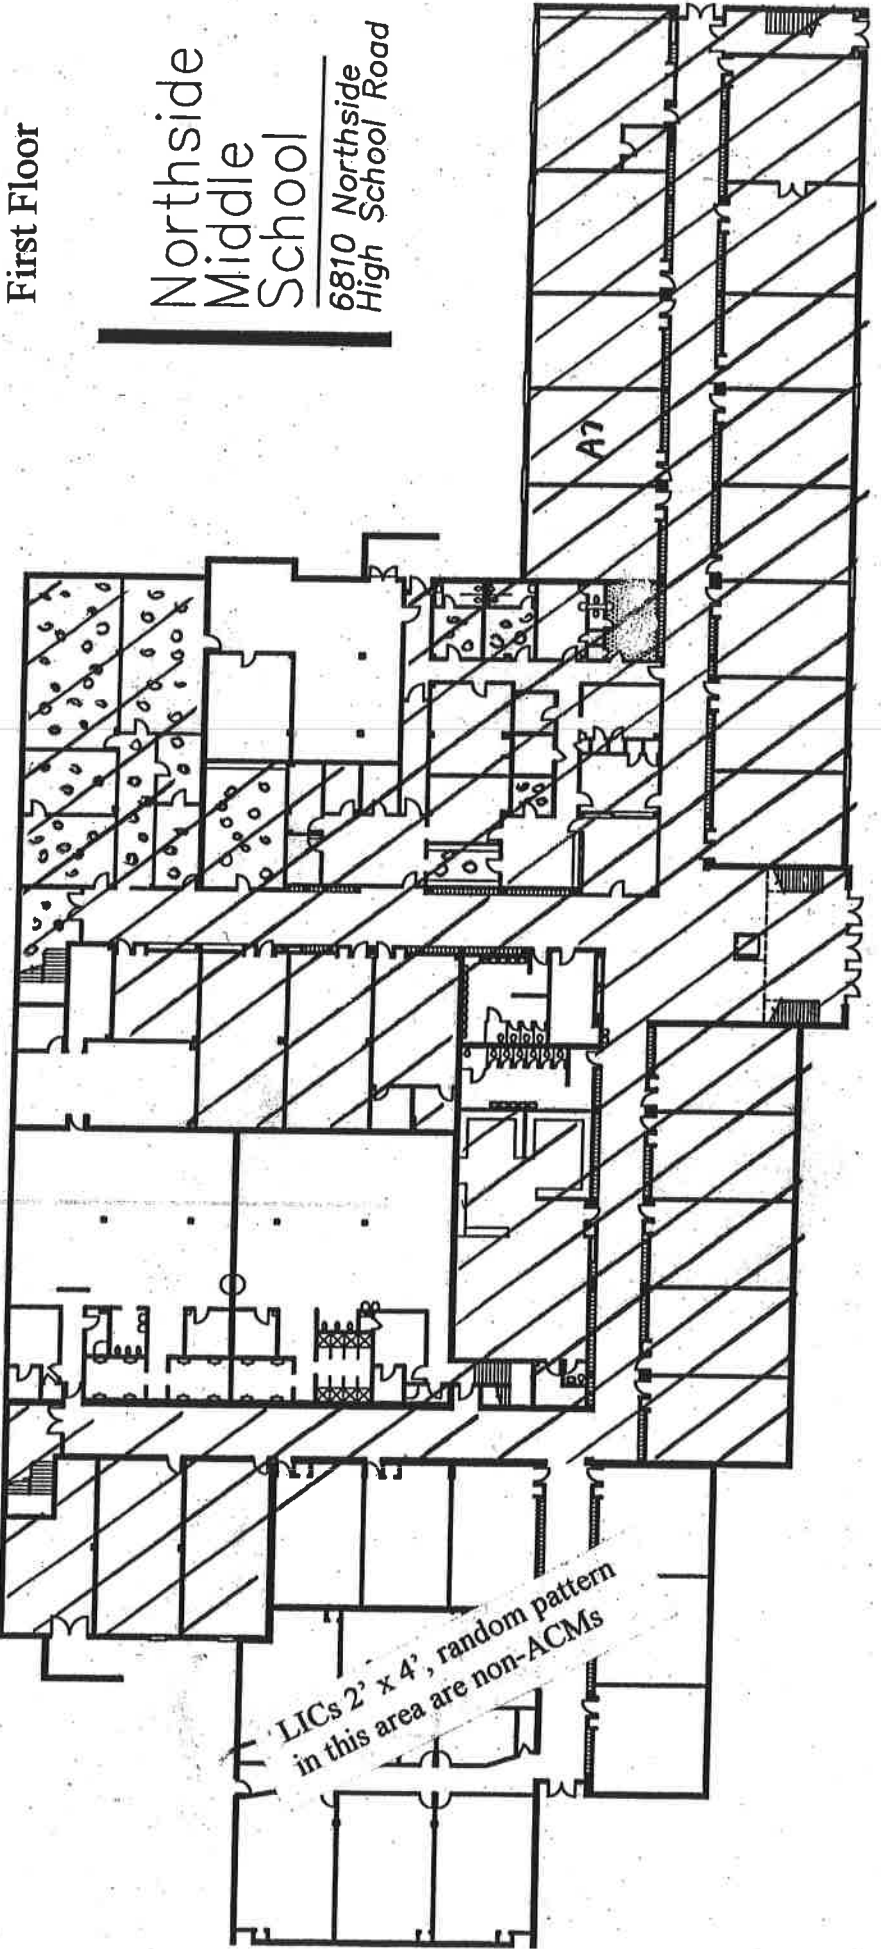
LOCATION OF ACBMs Northside Middle School

LICs 2' x 4', random pattern in this area are non-ACMs

Each Location	Recommended Response Actions	Scheduled To Begin	Scheduled To Be Completed	Est. Cost To Remove
Floor tile and mastic 06 & 08	Place in O & M Plan until removed	none	none	5,000
Lay-in Ceiling Panels* (LIC) 04A, 04B, 04D	Place in O & M Plan until removed	none	none	75,000
