Roanoke County Schools

Three Year AHERA Reinspection

William Byrd High School
Facility 005

February 19, 2008

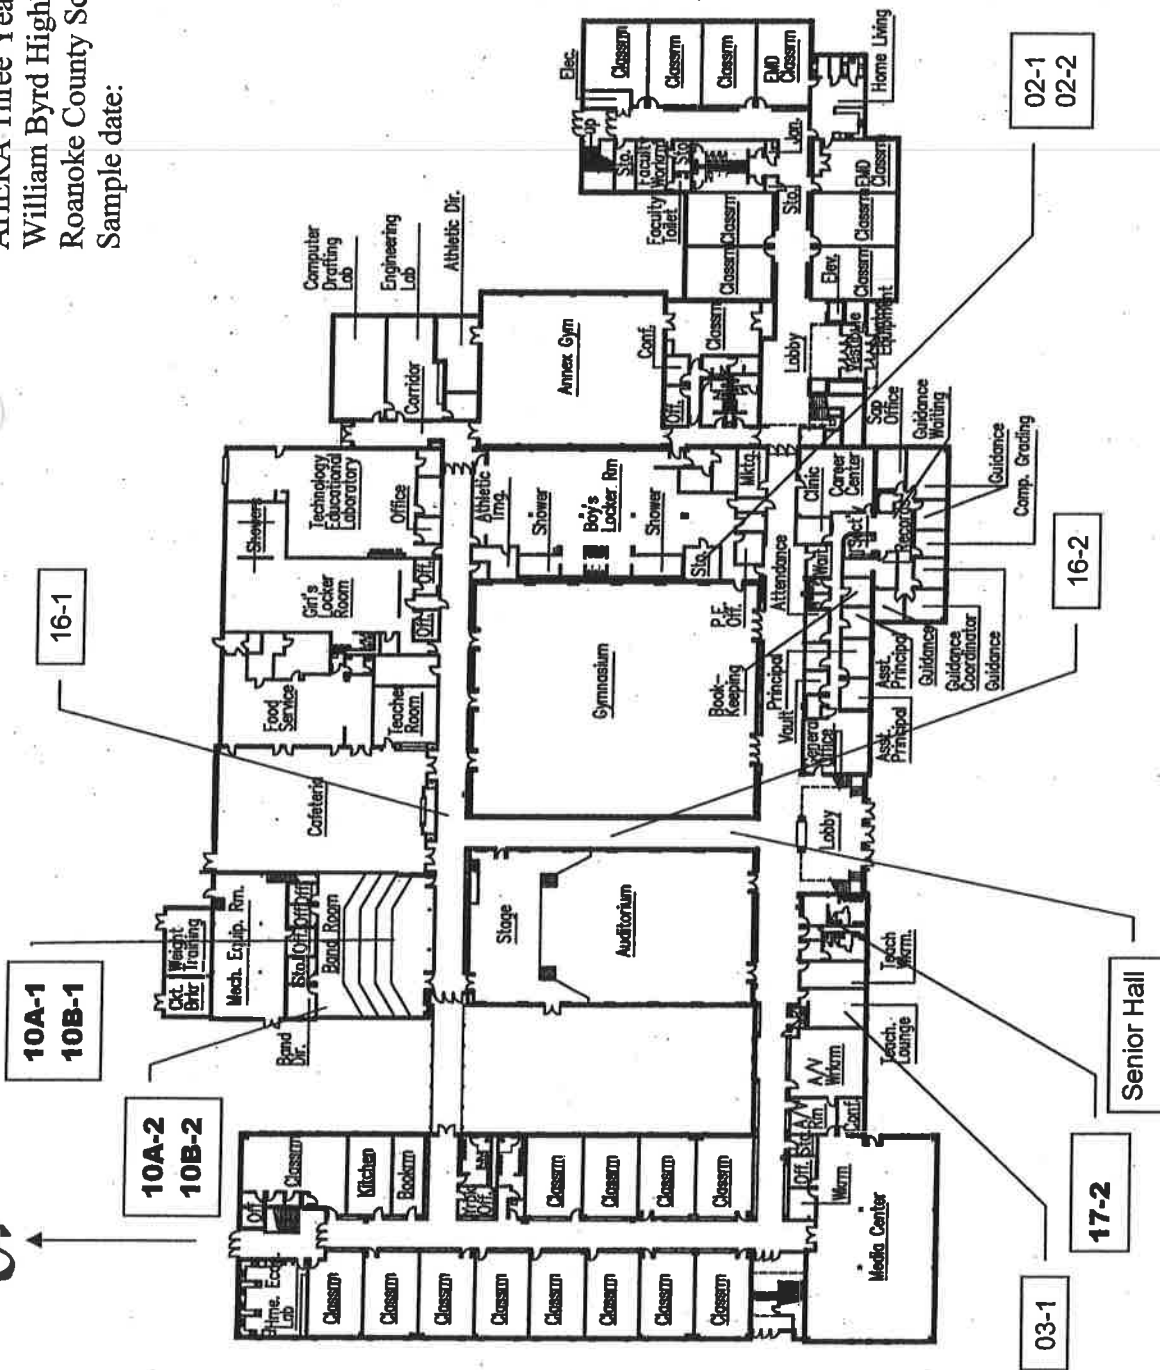
● First Floor Plan ●

- HA-02 LIC 2'x4', long holes parallel to short side
 Samples 02-1, 02-2
- HA-03 ACT 12"x12" parallel perforated pattern
 Samples 03-1, 03-2
- HA-10A Floor tiles 9"x9" cream & beige
 Samples 10A-1, 10A-2
- HA-10B Black mastic for HA-10A
 Samples 10B-1, 10B-2
- HA-16 LIC 2'x2' parallel holes
 Samples 16-1, 16-2
- HA-17 Black mastic on domestic water fiberglass
 Samples 17-1, 17-2

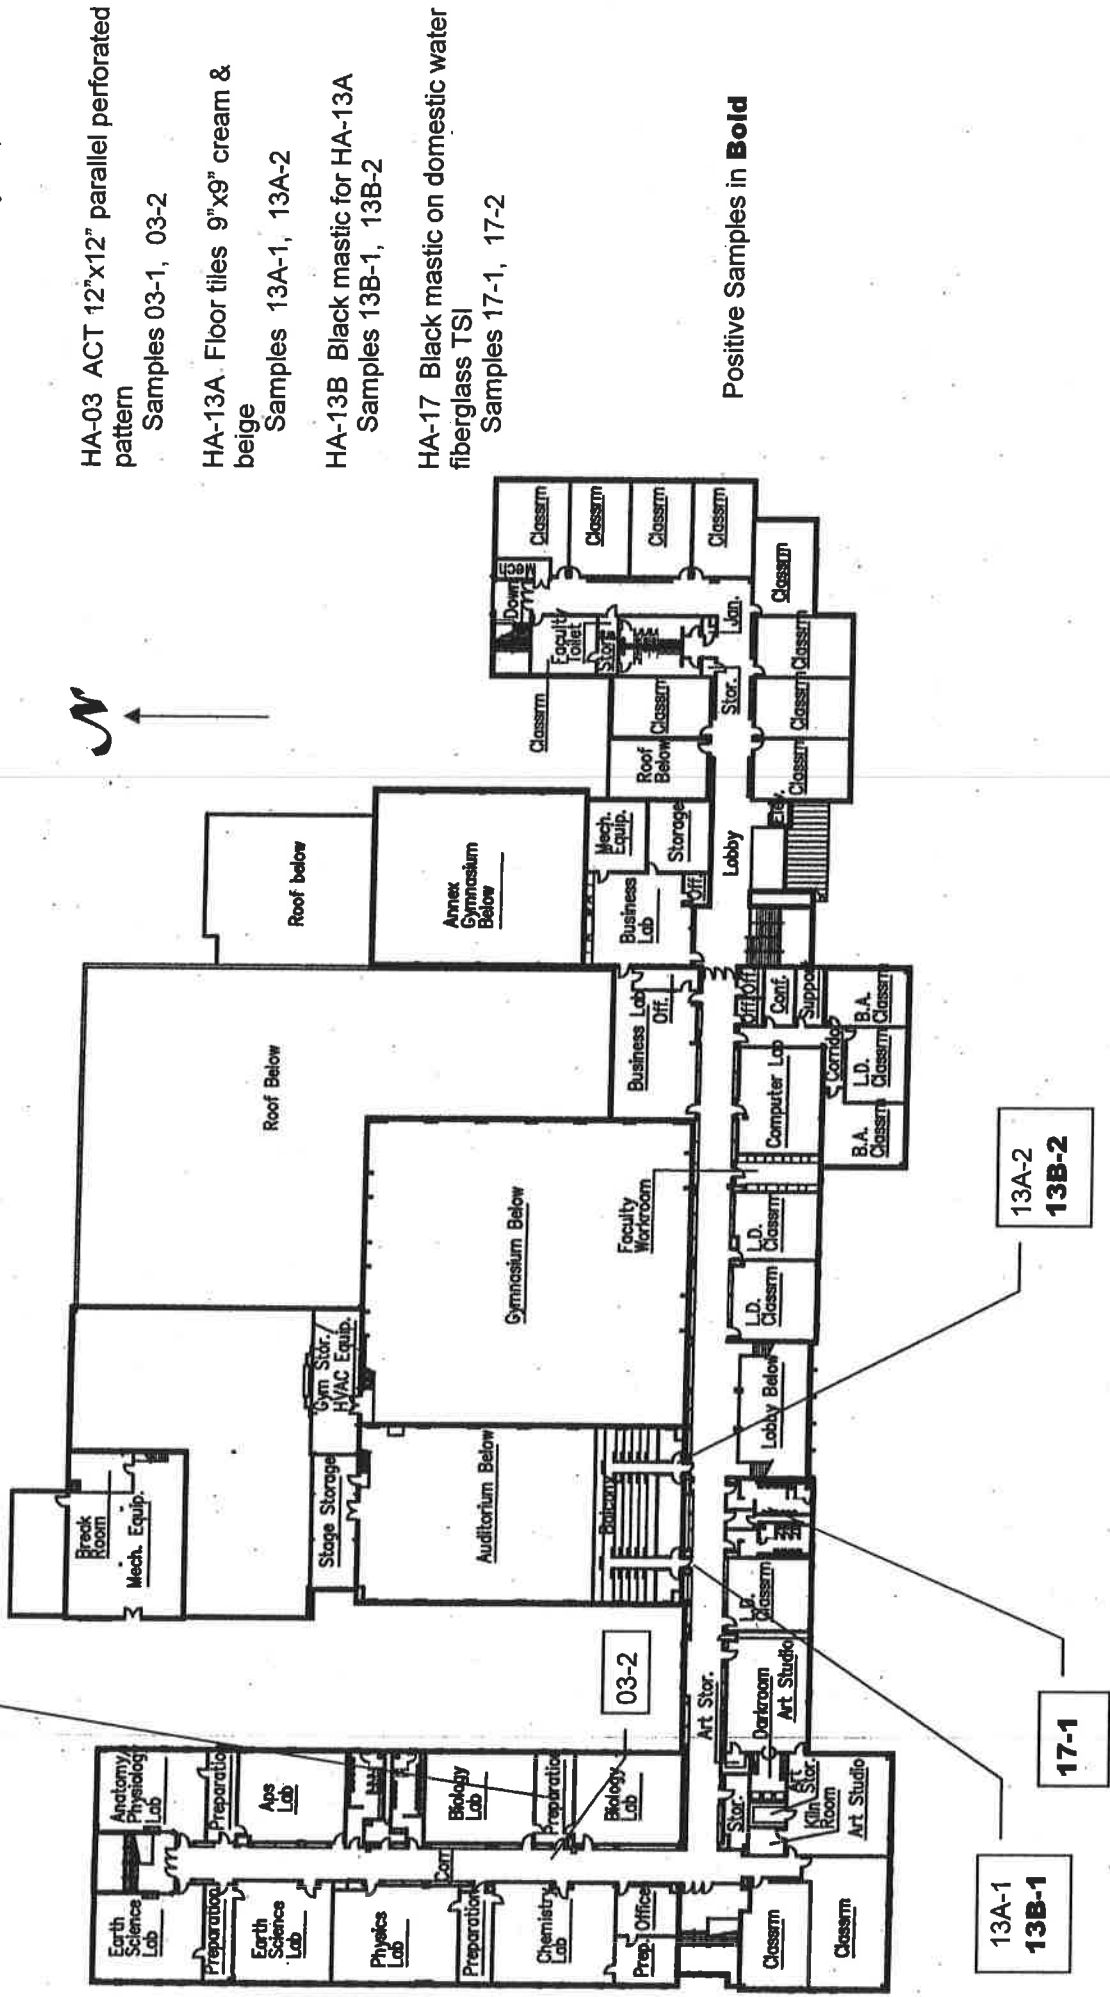
Second Floor Plan

HA-03 ACT 12"x12" parallel perforated pattern
 Samples 03-1, 03-2

HA-13A Floor tiles 9"x9" cream & beige
 Samples 13A-1, 13A-2

HA-13B Black mastic for HA-13A
 Samples 13B-1, 13B-2

HA-17 Black mastic on domestic water fiberglass TSI
 Samples 17-1, 17-2

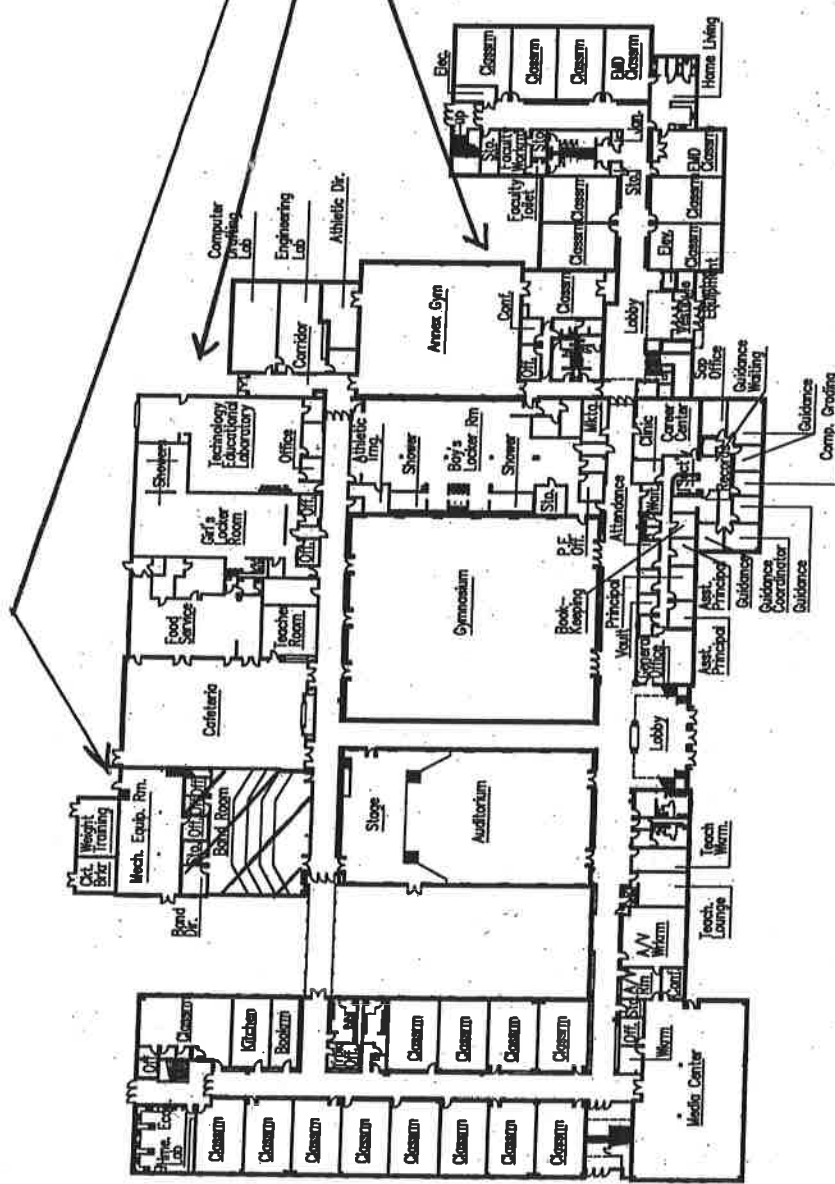
First Floor Plan

Asbestos containing fitting TSI and black mastic on domestic water system piping throughout building

Asbestos containing floor tile and mastic
--	---
